**Members are summoned to attend a meeting of the
Community & Culture Committee
To be held on Tuesday 13 February 2024 at 7.00 pm.
at Leigh-on-Sea Community Centre, 71-73 Elm Road SS9 1SP
in order to transact the following items of business**

- a) Skate Park Inspection Report – for consideration
- b) DEC 2023-24 Certificate & Recommendation Report 2023-30 Leigh Community Centre – for consideration
- c) Community Centre expenditure – Chairman of F&G Committee to report
- d) Hire rates – report from Booking staff – for consideration

Inspected: 15-December-2023 - 08:15 by Alan Lingley (RPII Annual Inspector)

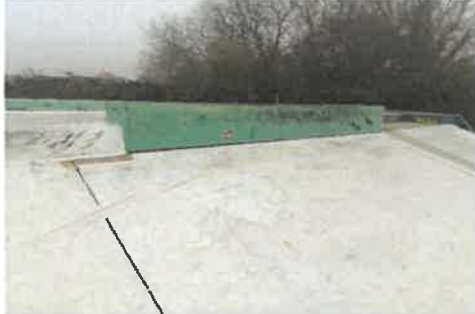
Item: Grind Box
Manufacturer: Not Identified
Surface Type: Concrete
Item Quantity: 1
Equipment Compliance: No
Surface Area Compliance: Yes

Total Findings: 4

Finding 1 There are cracks within the surface - Repair	Finding 2 The riding surface of the ramp is severely damaged - Repair all damaged surfaces
Finding 3 Height differences between the riding surfaces should not be greater than 3mm to meet the requirements of BS EN 14974 - Take corrective action to ensure that the gaps between the joints do not exceed 3mm	Finding 4 The sides of the ramp are damaged - Repair all damaged surfaces

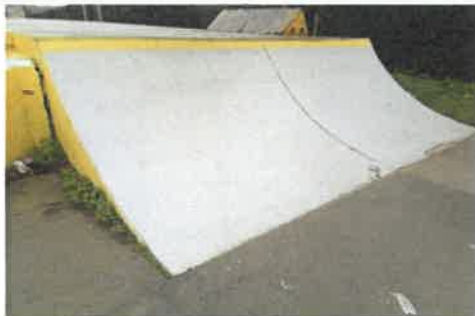
Item: Quarter Pipe
Manufacturer: Not Identified
Surface Type: Concrete
Item Quantity: 1
Equipment Compliance: No
Surface Area Compliance: Yes

Total Findings: 3

Finding 1 The sealant is missing on the platform - Replace	Finding 2 The riding surface of the ramp is damaged - Repair all damaged surfaces
Finding 3 Height differences should not be greater than 3mm to meet the requirements of BS EN 14974 - Take corrective action to ensure that the gaps between the joints do not exceed 3mm

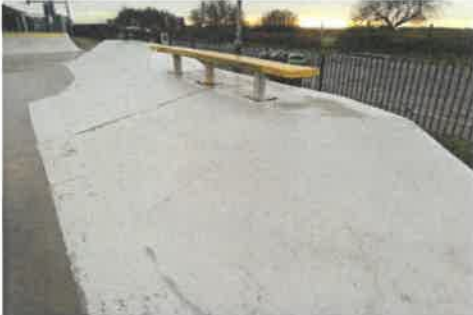
Item:	Bank/ Wedge Ramp
Manufacturer:	Not Identified
Surface Type:	Concrete
Item Quantity:	1
Equipment Compliance:	No
Surface Area Compliance:	No

Total Findings: 6

Finding 1	Finding 2
The item has insufficient safety zone allowed as required by BS EN 14974. This should equal at least 2.0 metres on most items. - Monitor - No remedial work recommended	There is minor damage to the side - Monitor for any further deterioration and repair as required
Finding 3	Finding 4
The paintwork on this item has been damaged or worn exposing the metal underneath which is rusting / corroding - Treat affected areas and repaint	The riding surface of the ramp has some damage apparent - Repair as required
Finding 5	Finding 6
There is / are sheared fixing/s present - Replace	The riding surface of the ramp has some damage apparent - Repair

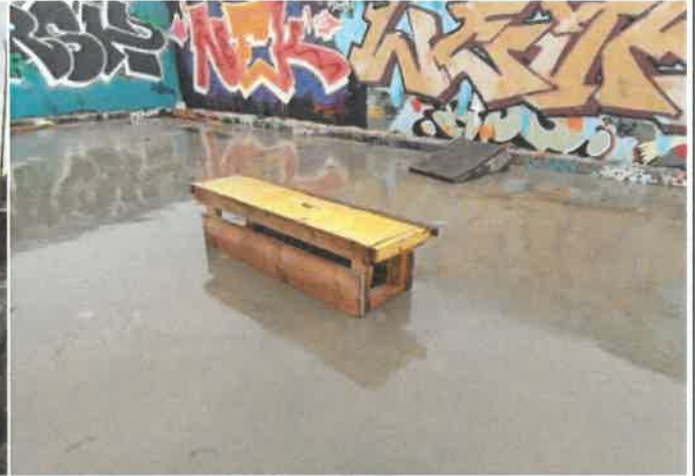
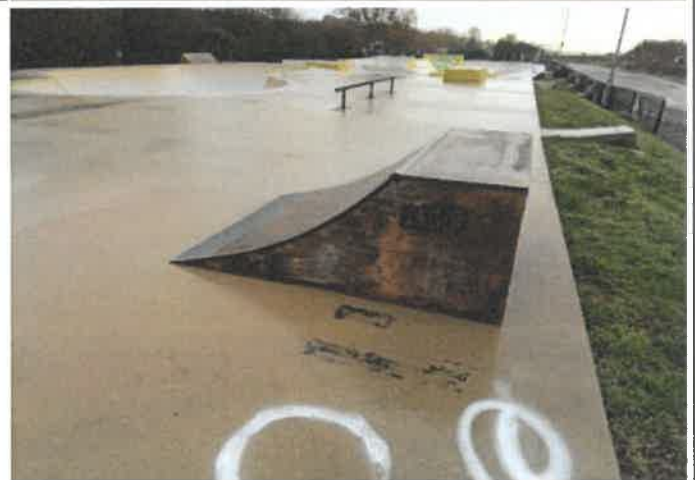
Finding: Home-made portable skate ramps are present on site **Action:** Remove

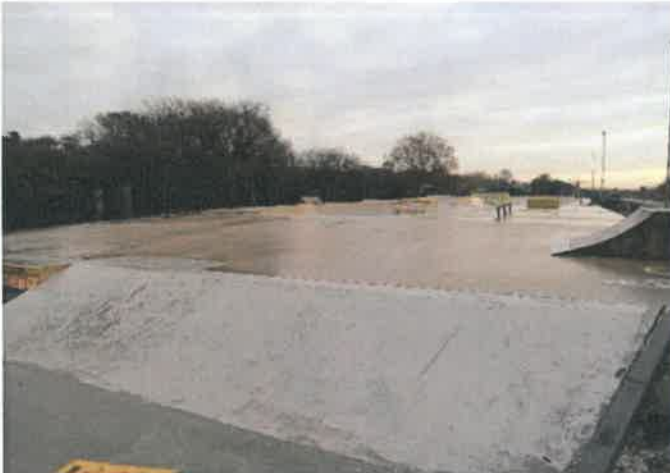
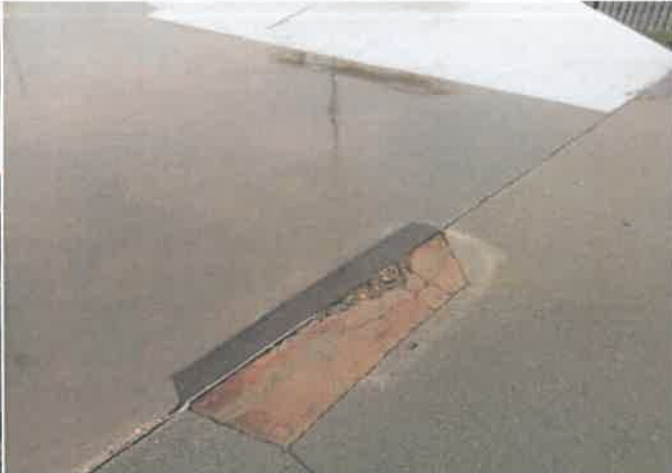
Finding: The rolling surface of the area is severely damaged

Action: Repair all damaged surfaces

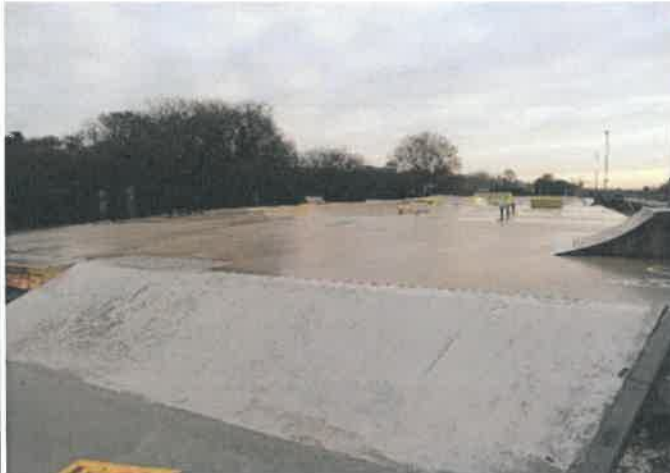
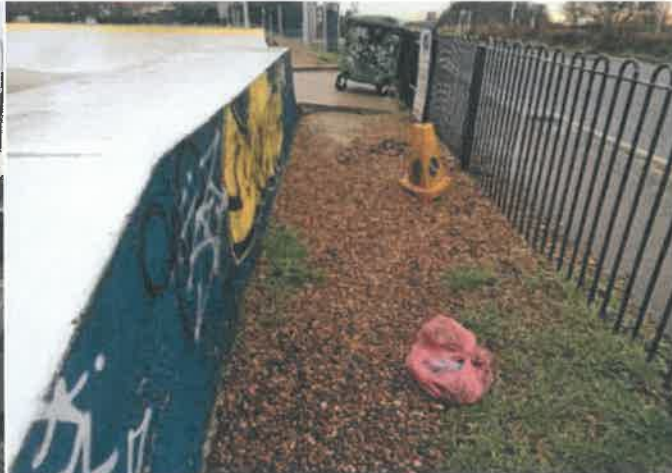
Finding: The skate safety zone shall be a bound uniform and loose fill shall not be used

Action: Remove loose fill and provide a bound surface

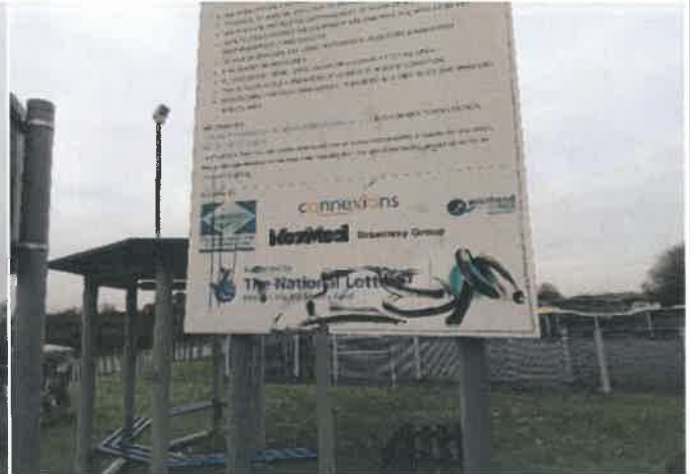
Finding: There is some graffiti present

Action: Remove the graffiti

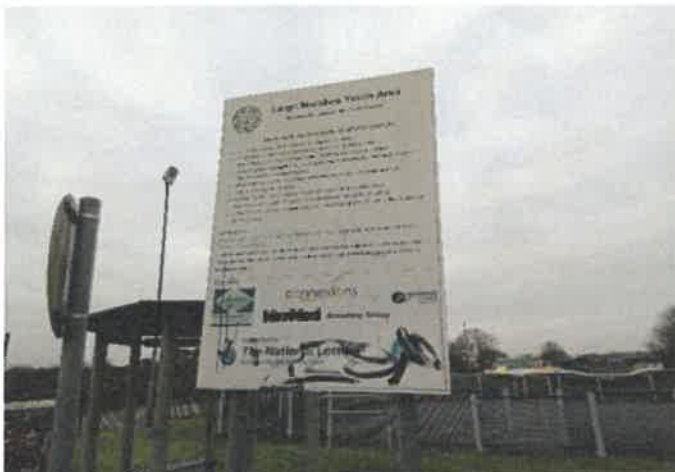
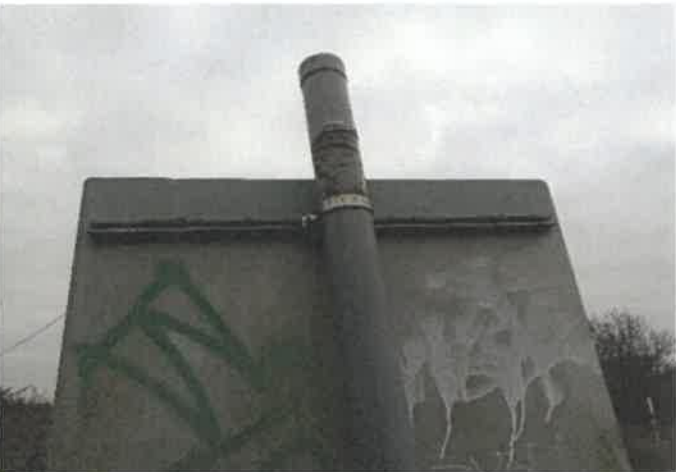
Finding: The paintwork on this item has been damaged or worn exposing the metal underneath which is rusting / corroding

Action: Treat affected areas and repaint

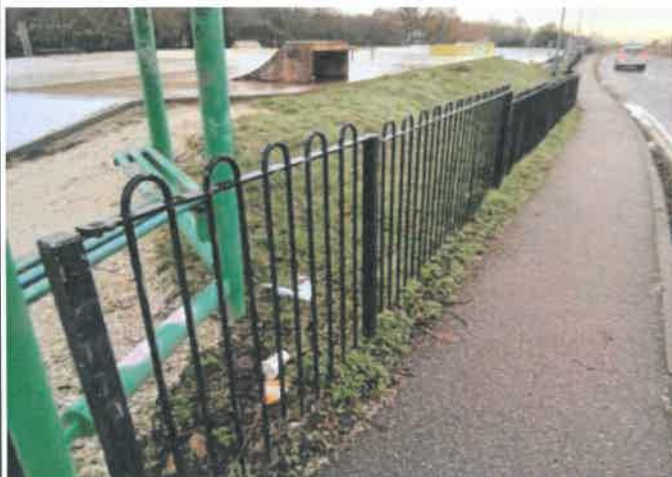
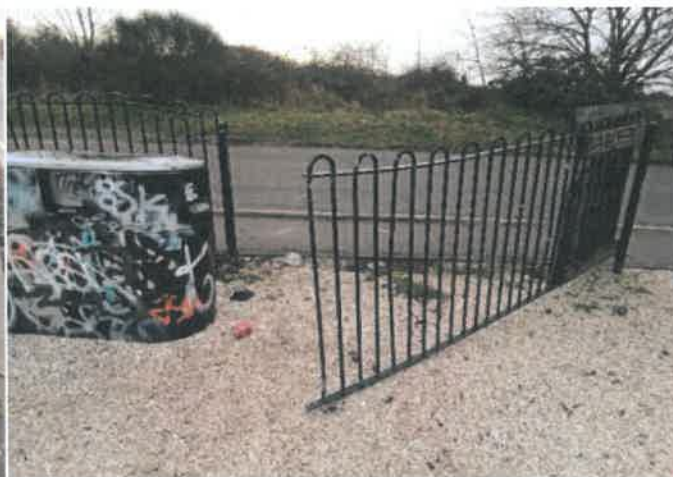
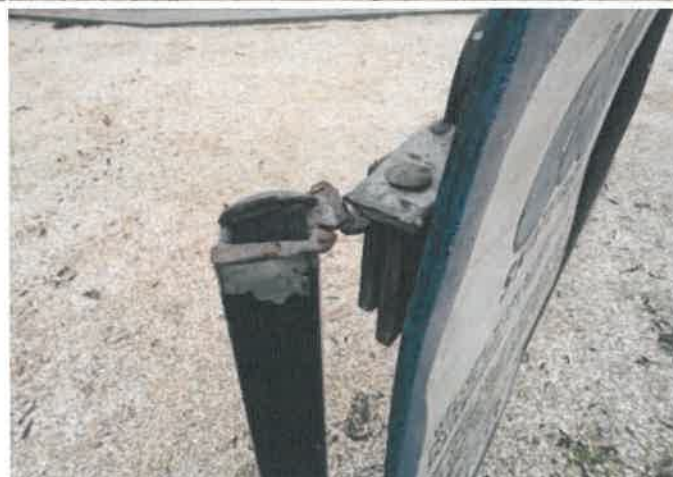
Finding: A section of fence is damaged and unsecured

Action: Repair and secure

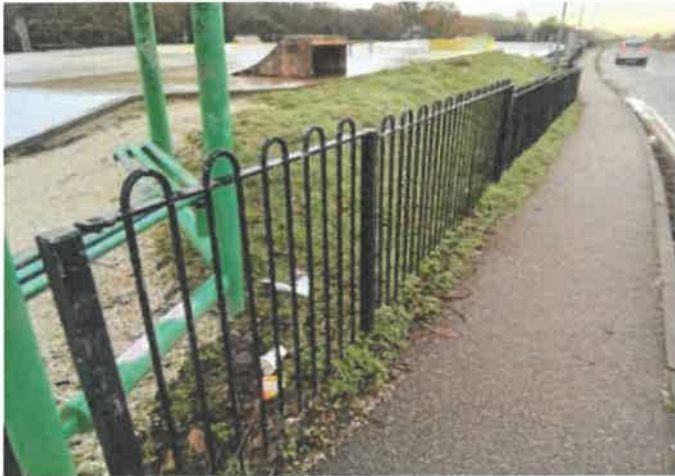
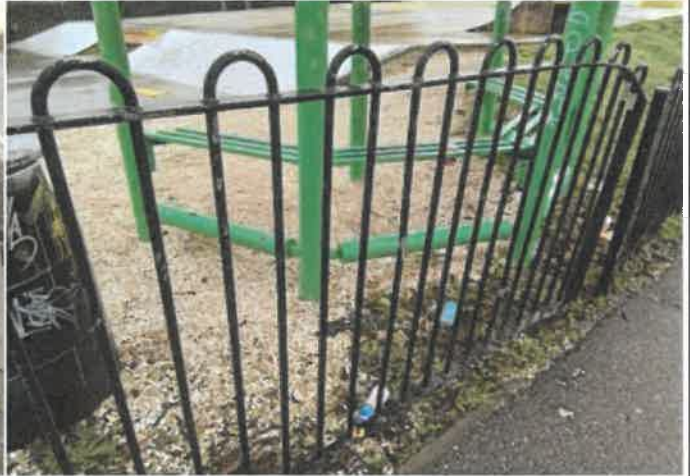
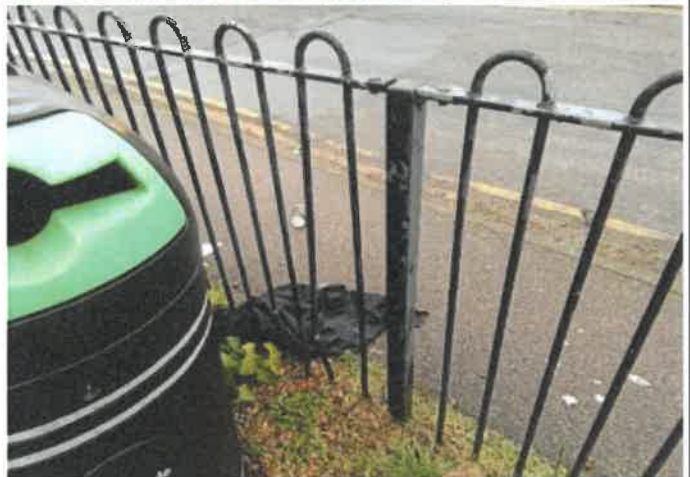
Finding: There is some damage to the fence sections

Action: Monitor for any further deterioration and repair as required

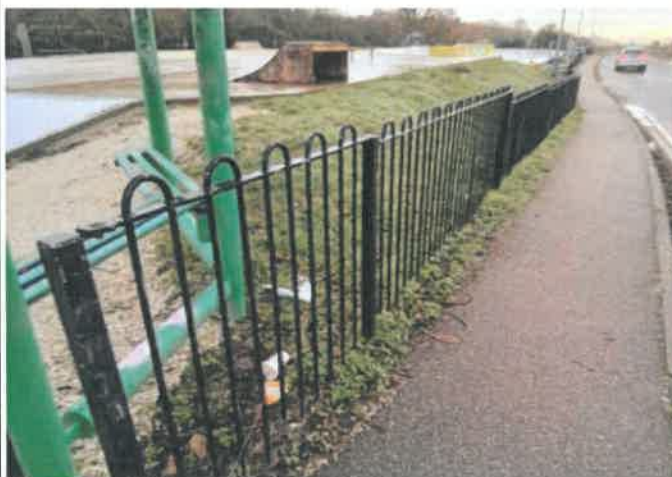
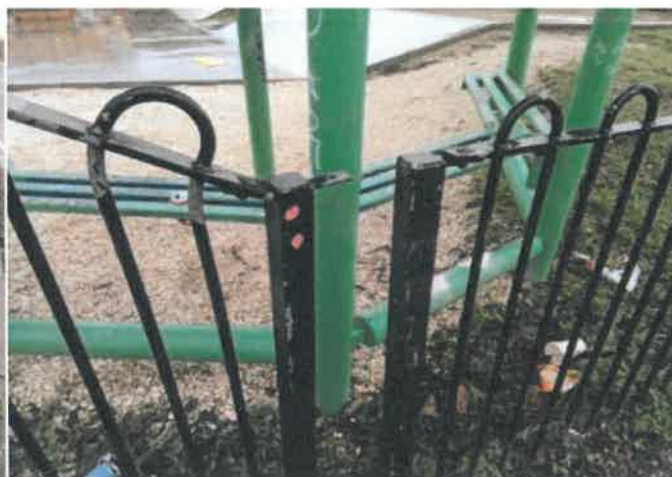
Finding: There is some damage to the fence

Action: Repair

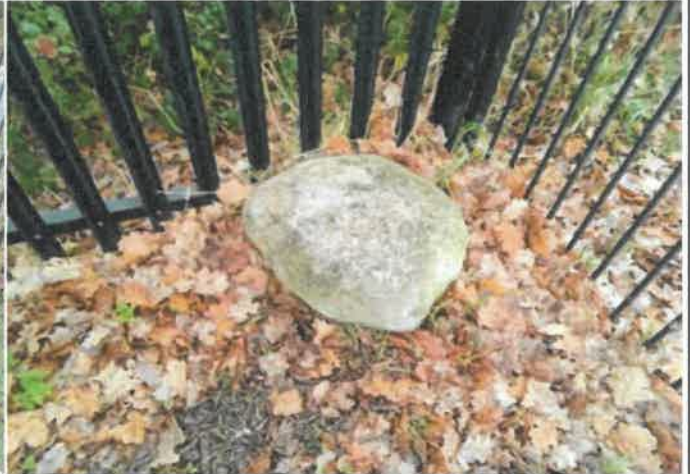
Finding: The boulders are not secured into position

Action: Secure the boulders

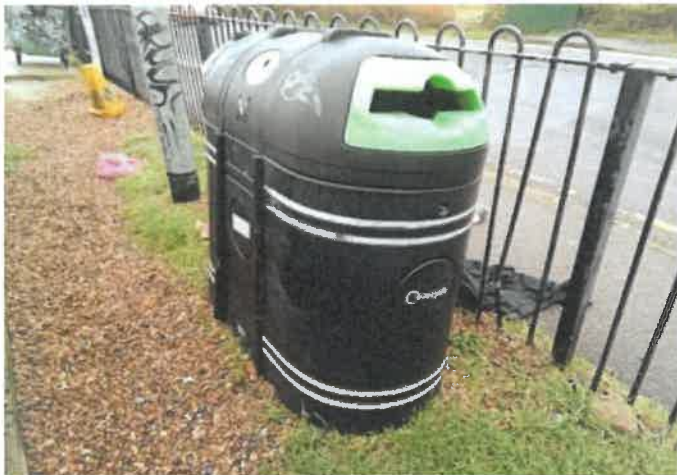
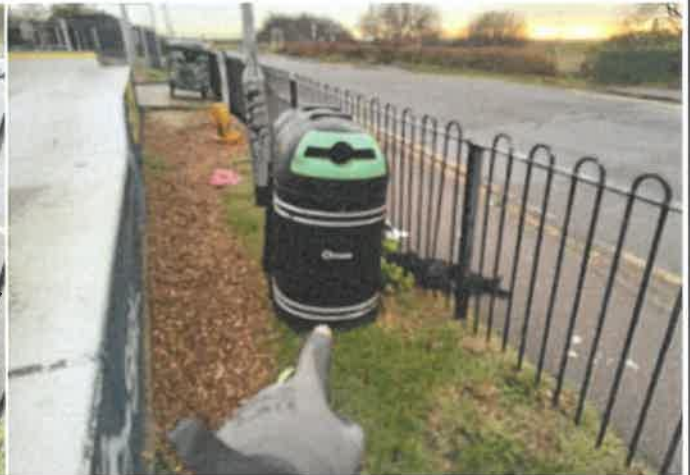
Finding: A number of fixing(s) have worked loose

Action: Secure all loose fixings

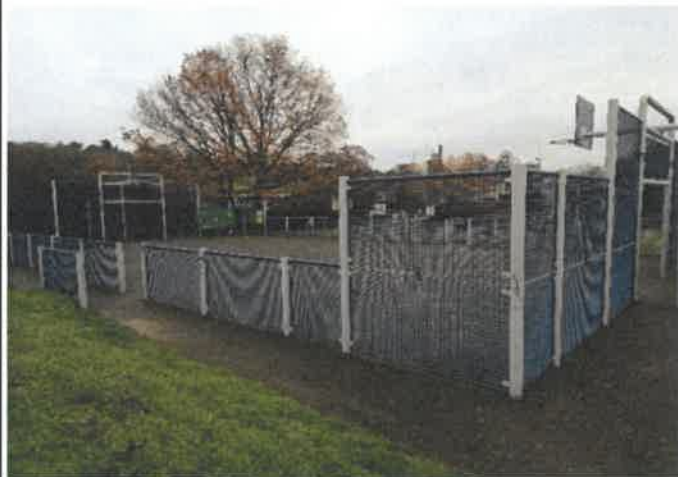
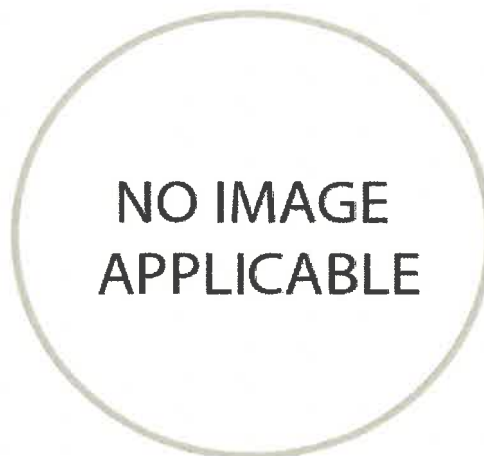
Finding: A clearly visible facility sign should be provided in a prominent position with the wording as detailed BS EN 15312- the equipment is not intended for children less than 3 years old- the warning - Do not climb on the framework or nets- the warning - Do not hang on the ring (if provided)- the warning - Do not wear rings or other jewellery- name and telephone number of the administrator- number to call in case of accident **Action:** Provide signage to BS EN 15312

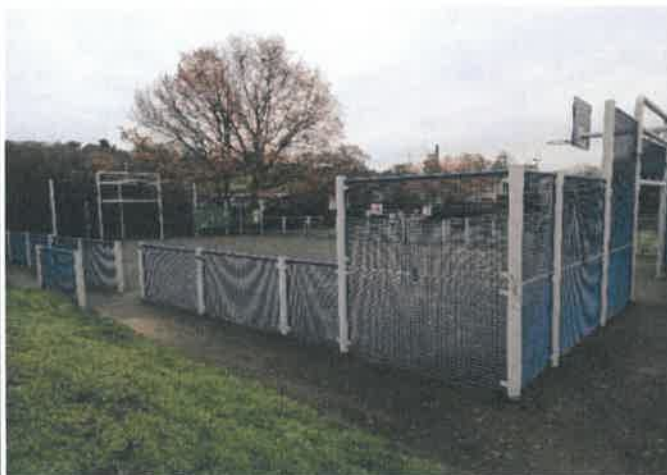
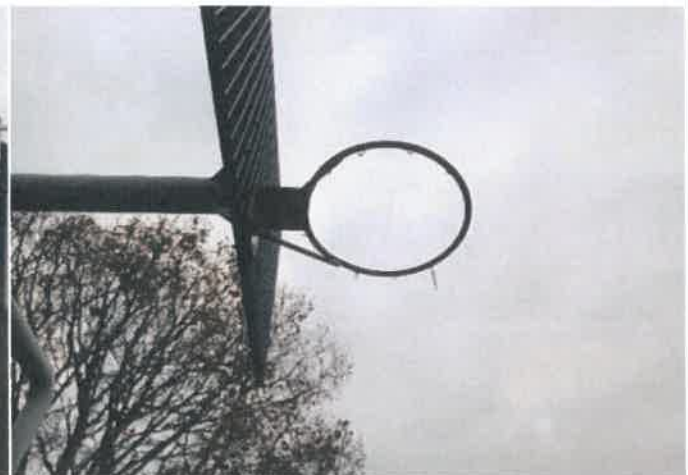
Finding: The net is damaged
Action: Replace

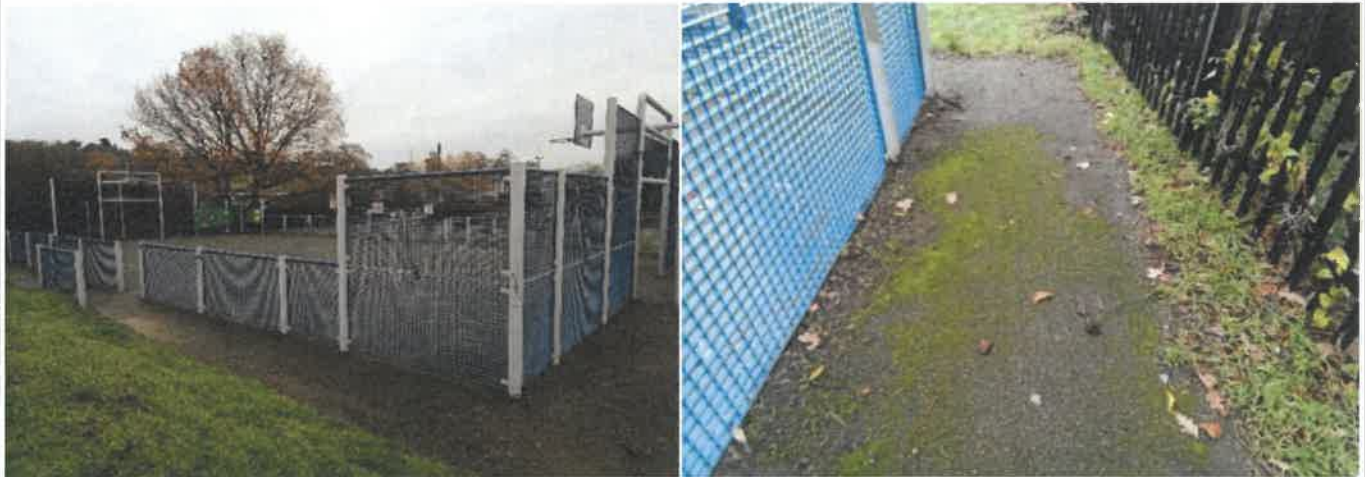
Finding: There is algae, silt or moss growth on the surface resulting in slippery conditions
Action: Clean and treat appropriately

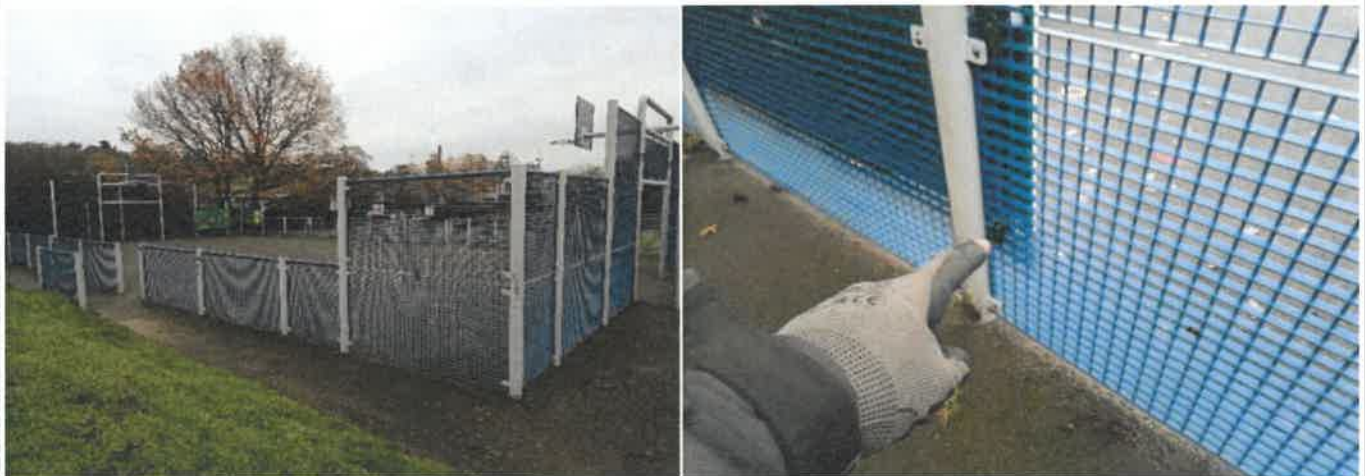
Finding: A number of fixing(s) have worked loose
Action: Secure all loose fixings

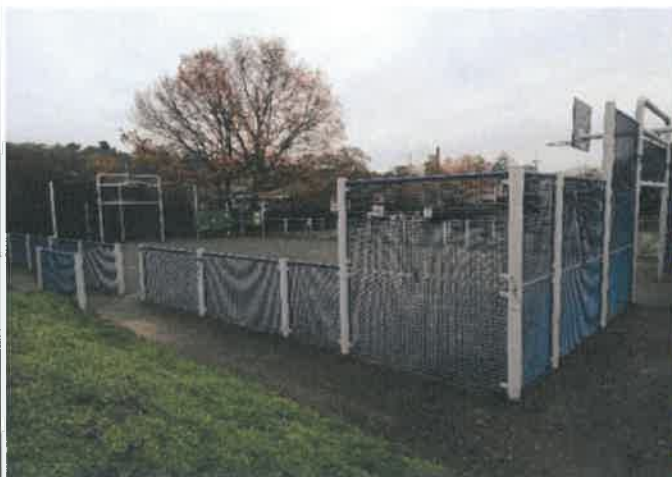
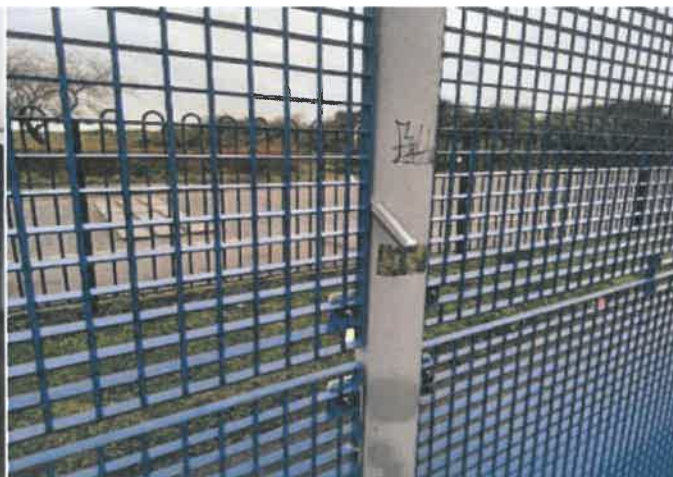
Finding: There is/are finger entrapments in the panels and the item fails to meet the requirements of BS EN 15312 Clause 4.4.2.2 Entrapment of fingers
Action: Monitor - No remedial work recommended

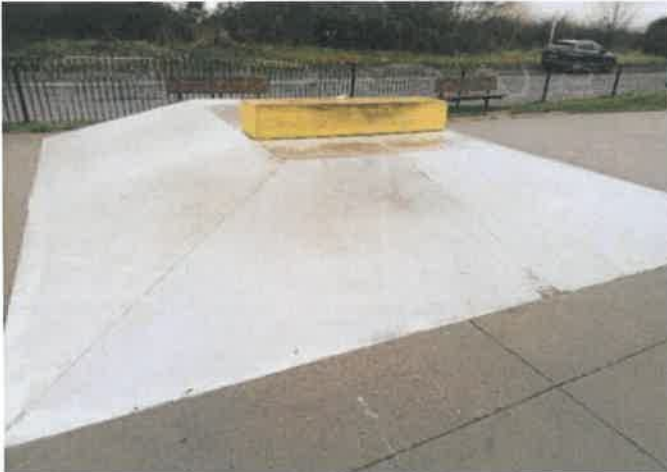
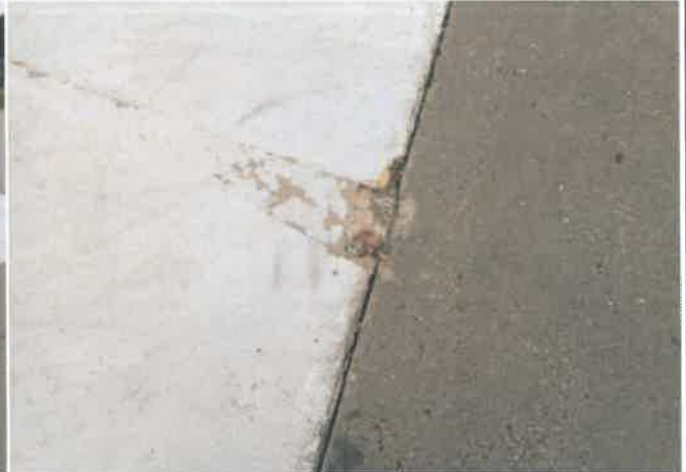
Finding: The riding surface of the ramp is damaged

Action: Repair all damaged surfaces

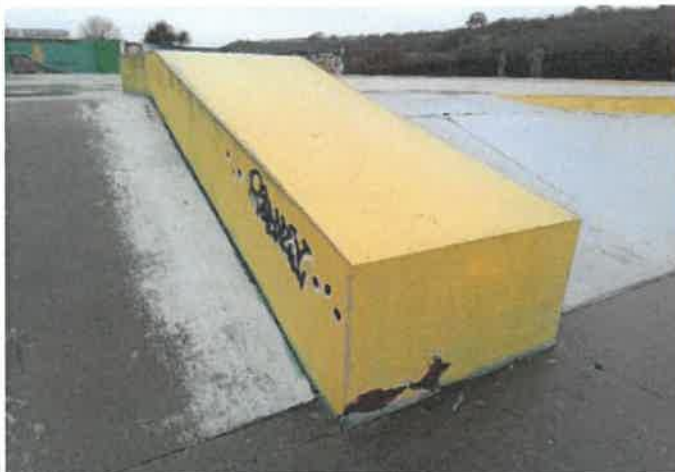
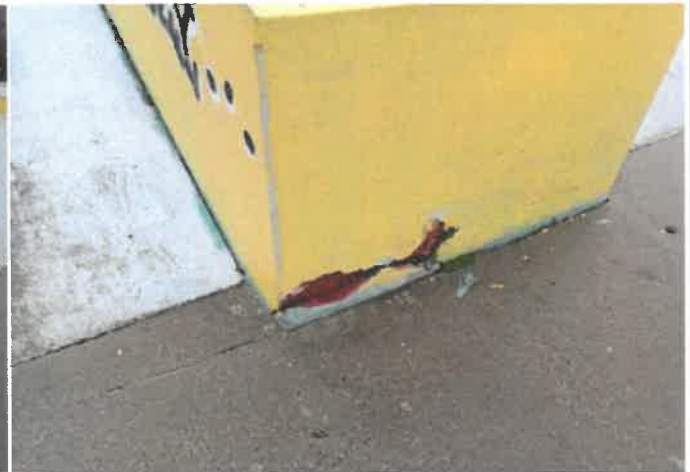
Finding: There is damage to the grind box

Action: Repair the box

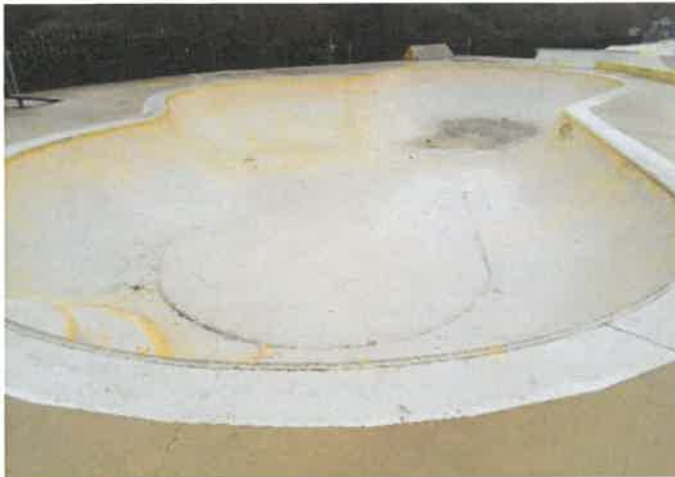
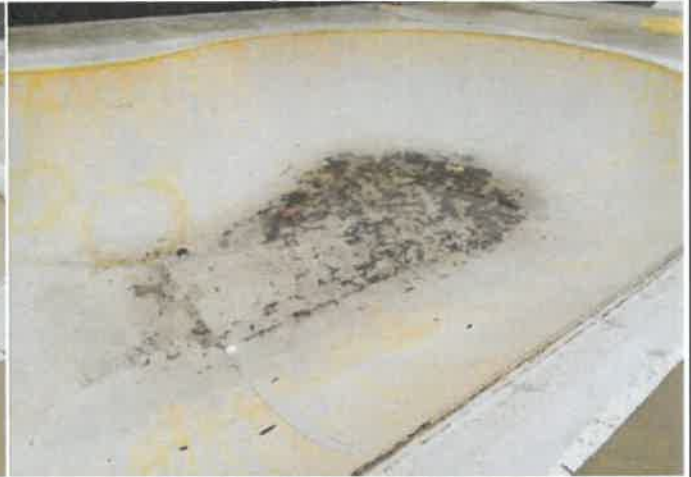
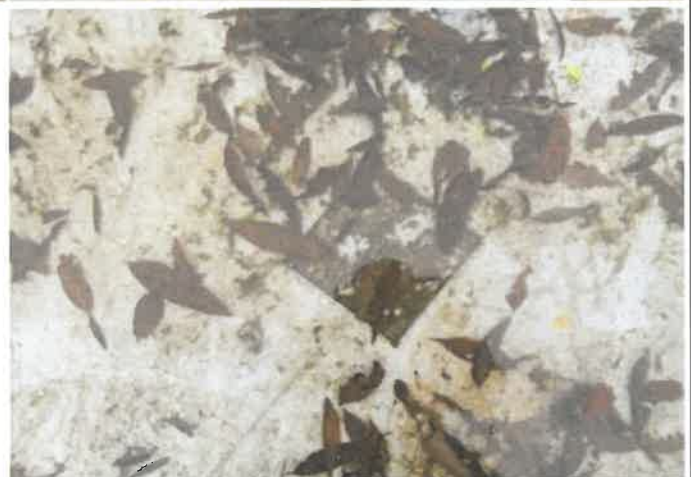
Finding: There is standing water within the bowl and the drain cover is damaged

Action: Replace the drain cover and ensure the water drains freely

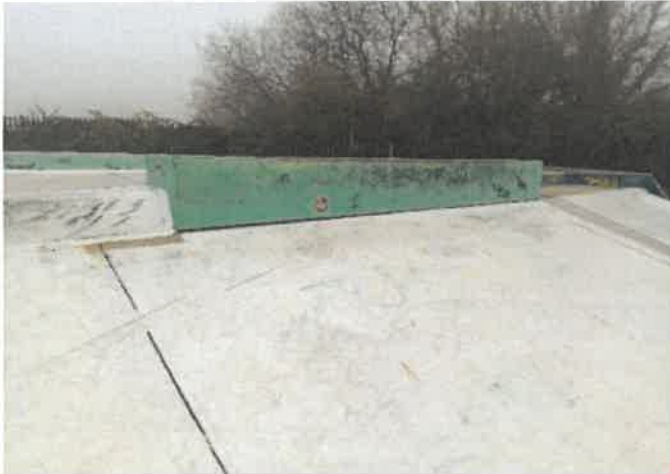
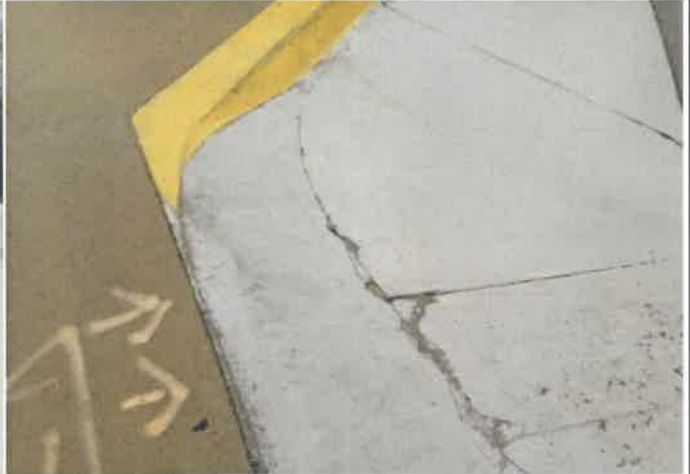
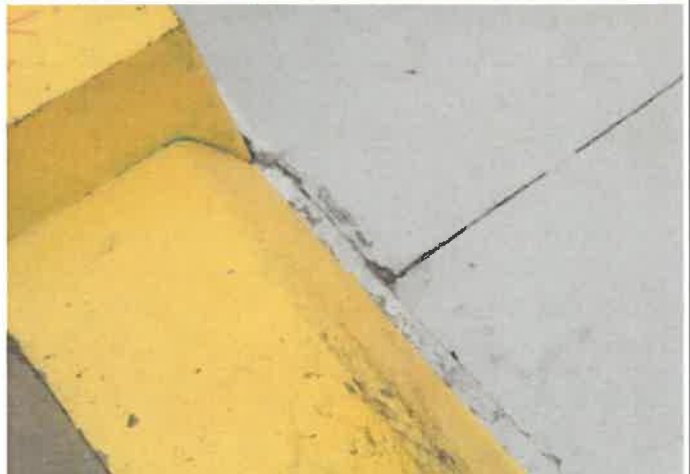
Finding: There are cracks within the surface

Action: Repair

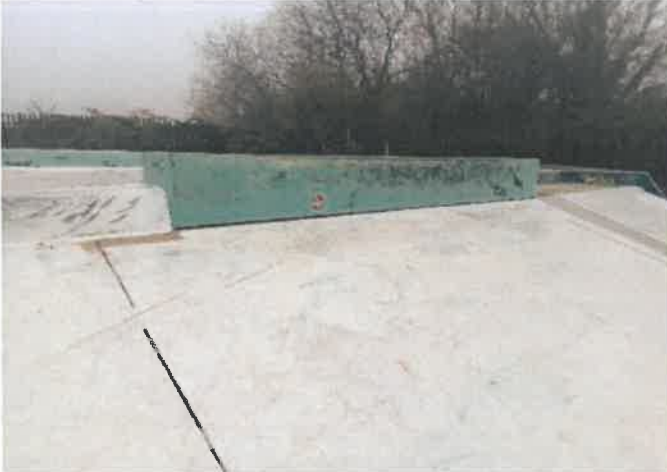
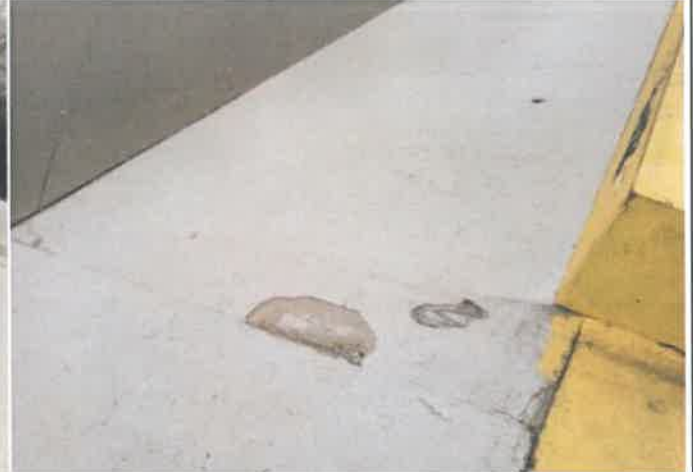
Finding: The riding surface of the ramp is severely damaged

Action: Repair all damaged surfaces

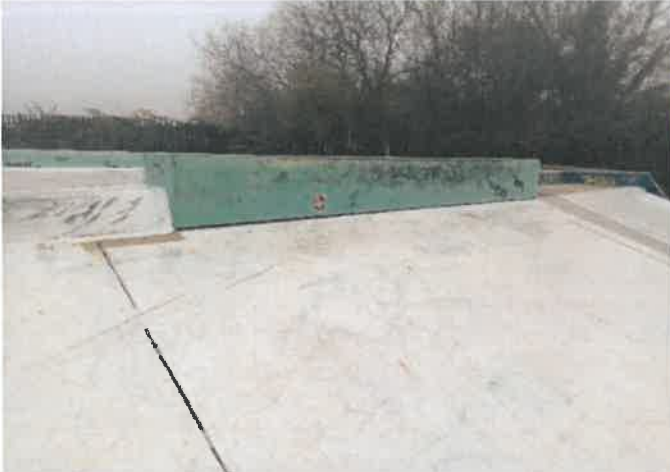
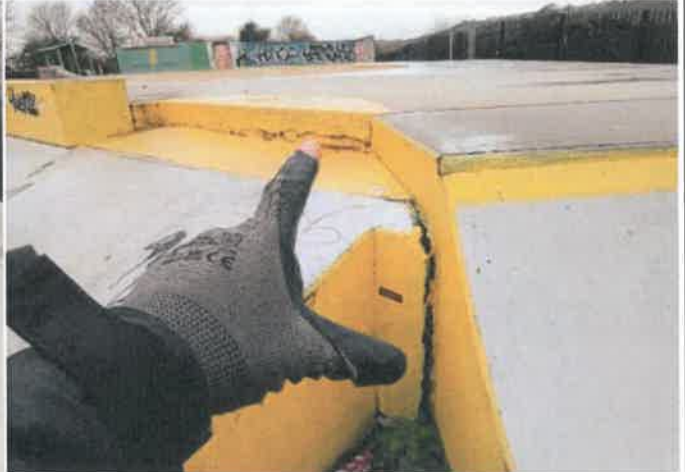
Finding: The sides of the ramp are damaged
Action: Repair all damaged surfaces

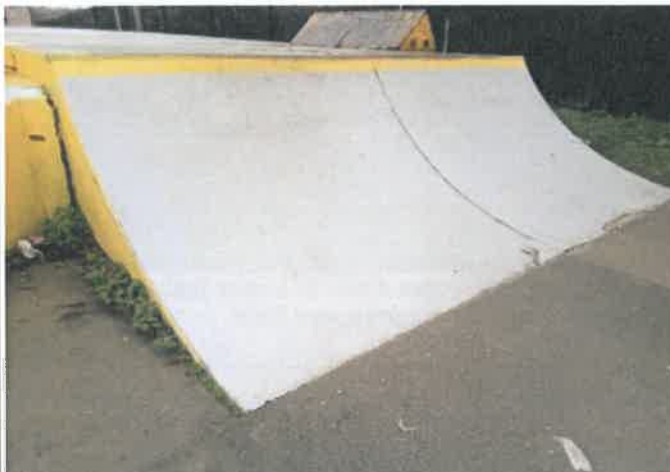
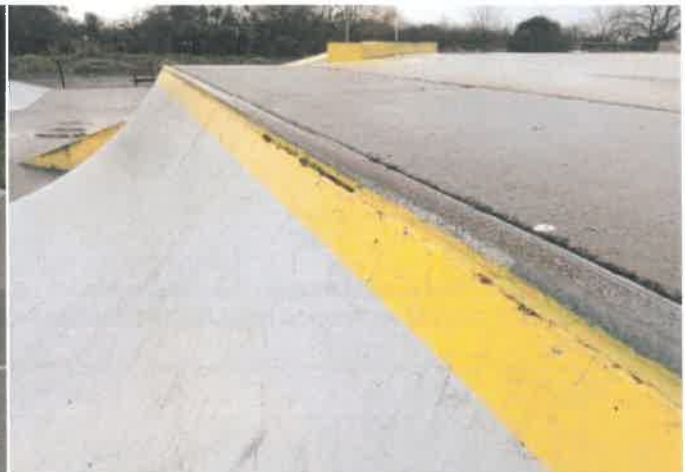
Finding: The sealant is missing on the platform
Action: Replace

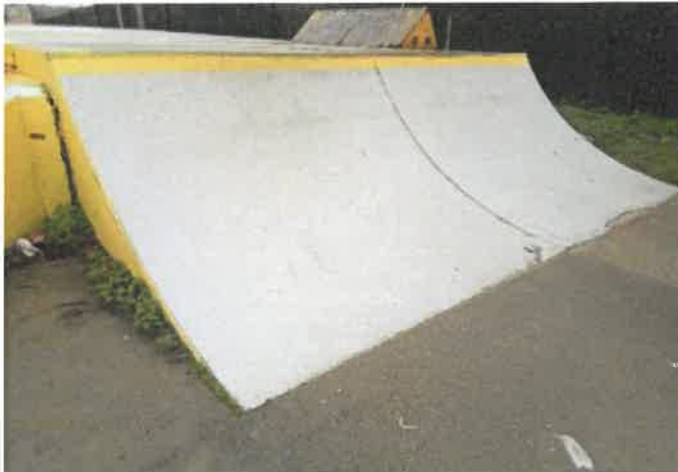
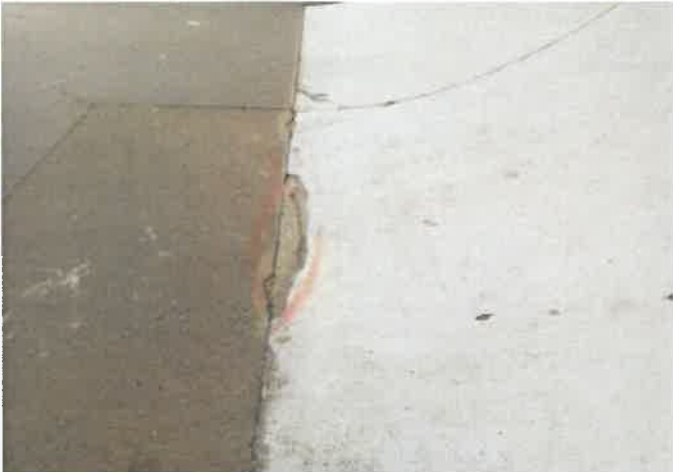
Finding: The riding surface of the ramp is damaged **Action:** Repair all damaged surfaces

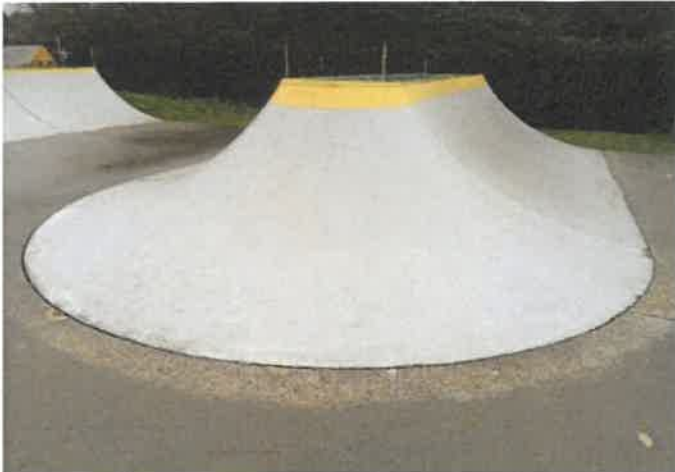
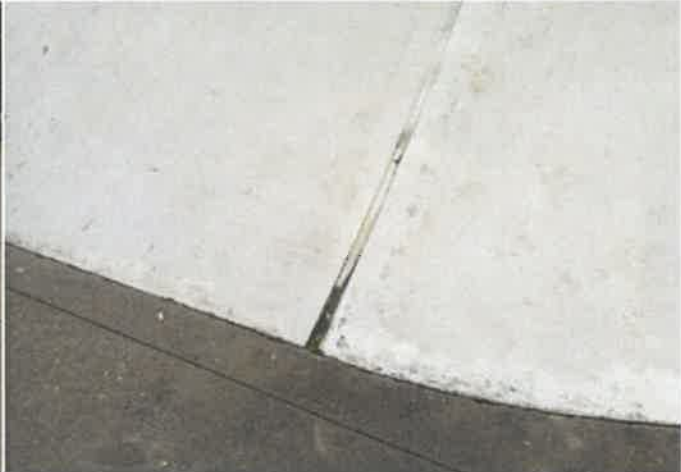
Finding: The riding surface of the ramp is damaged **Action:** Repair all damaged surfaces

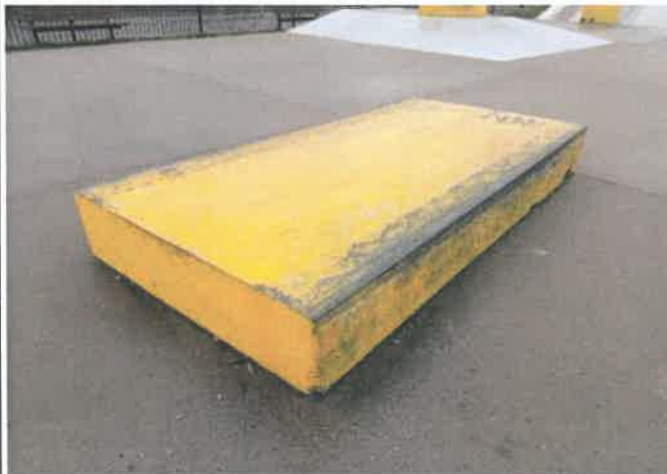
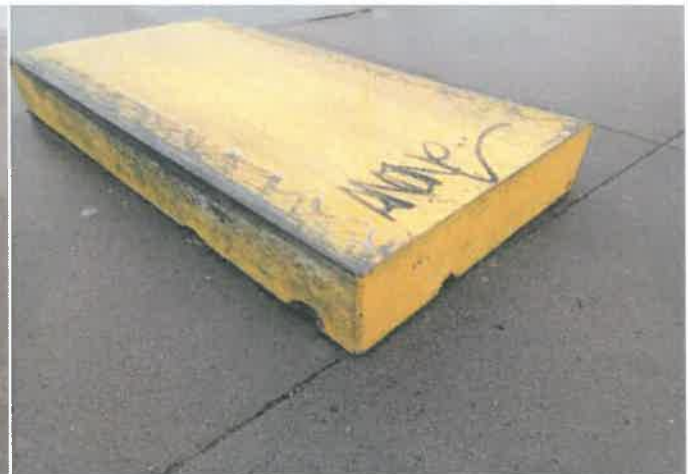
Finding: The item has been damaged

Action: Monitor for any further deterioration and replace as required

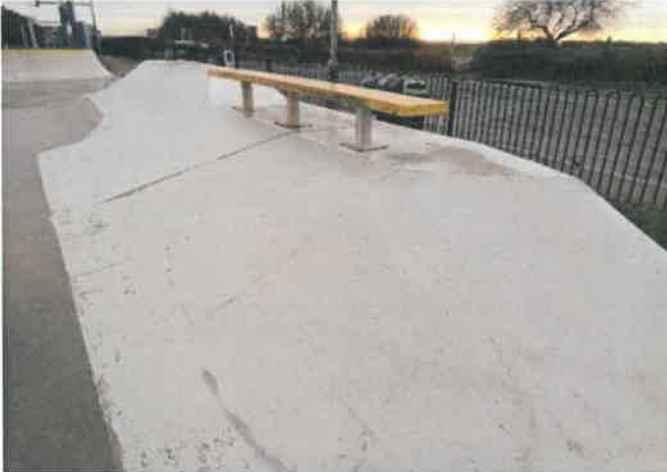
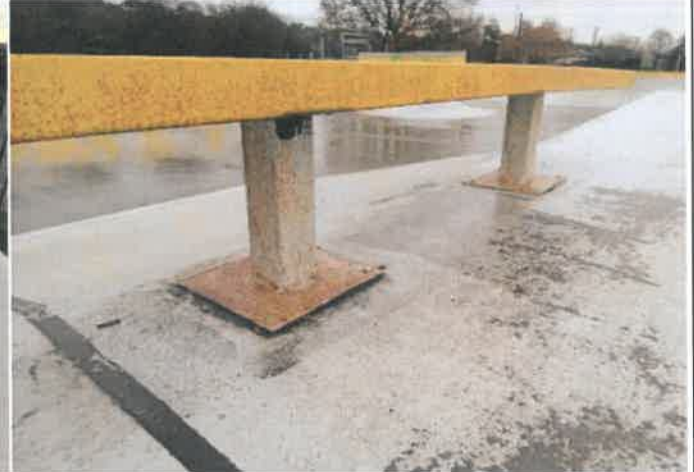
Finding: The paintwork on this item has been damaged or worn exposing the metal underneath which is rusting / corroding
Action: Treat affected areas and repaint

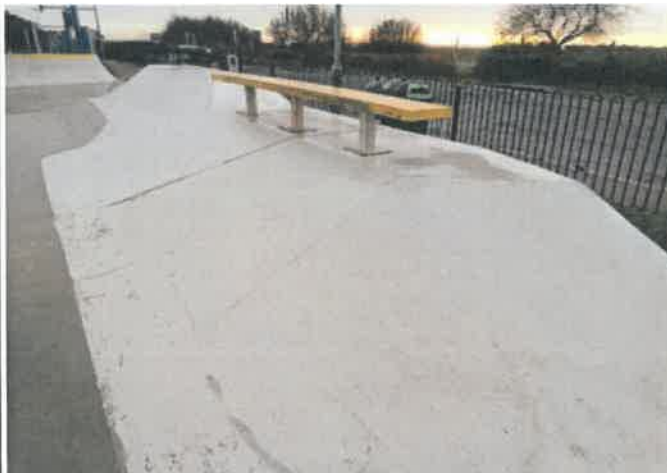
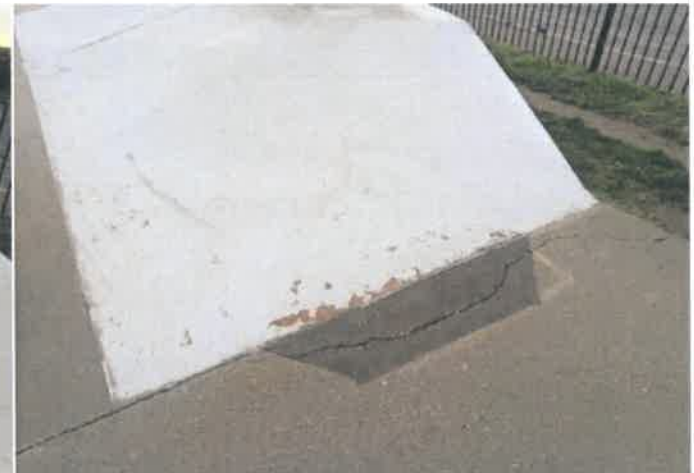
Finding: The riding surface of the ramp has some damage apparent
Action: Repair as required

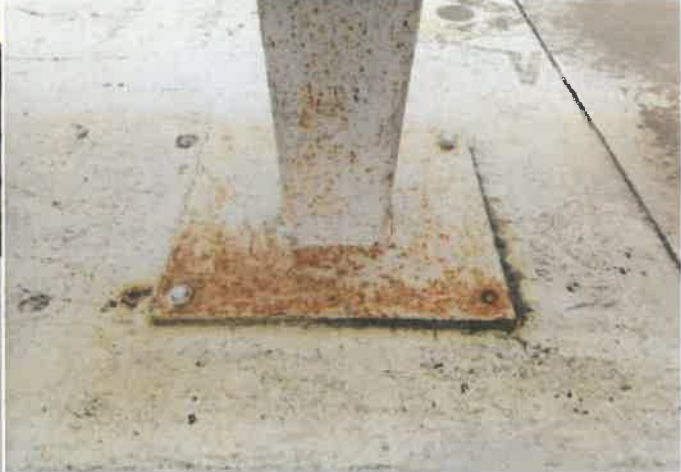
Finding: There is / are sheared fixing/s present **Action:** Replace

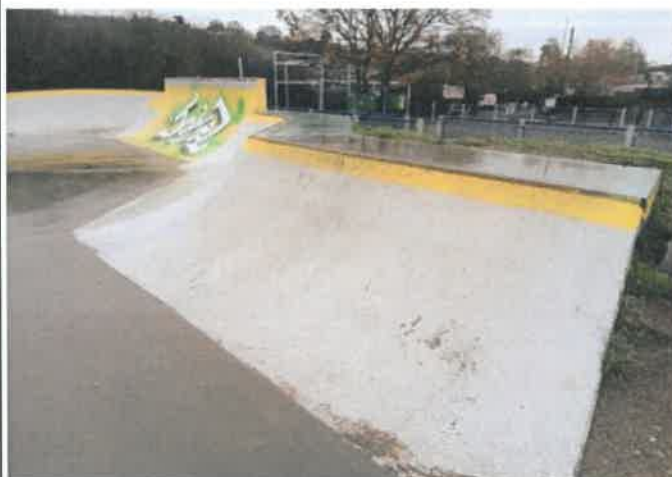
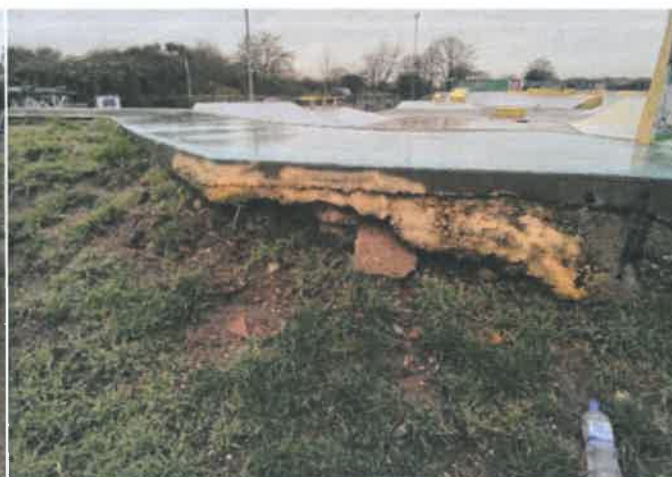
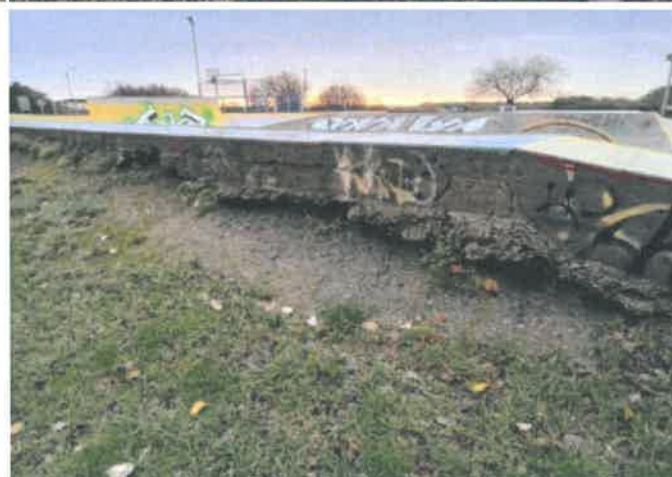
Finding: The surface has eroded in some areas exposing the concrete foundations

Action: Reinstate the surface

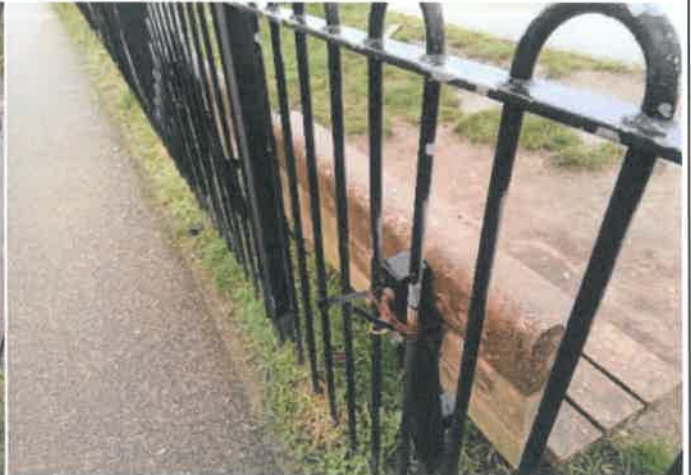
Finding: The bench is secured via cable ties

Action: Secure with a permanent fixing

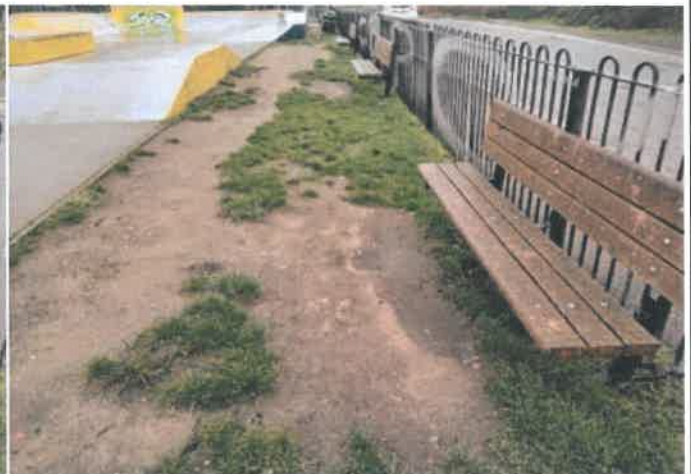
Finding: The area around the item has eroded and may become slippery

Action: Reinstate eroded area

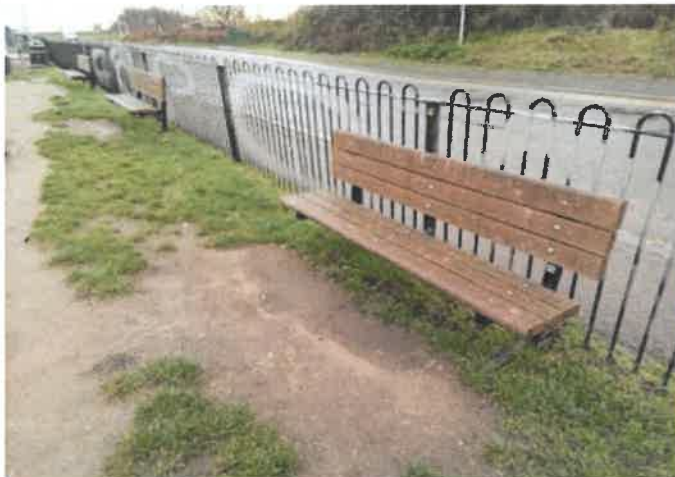
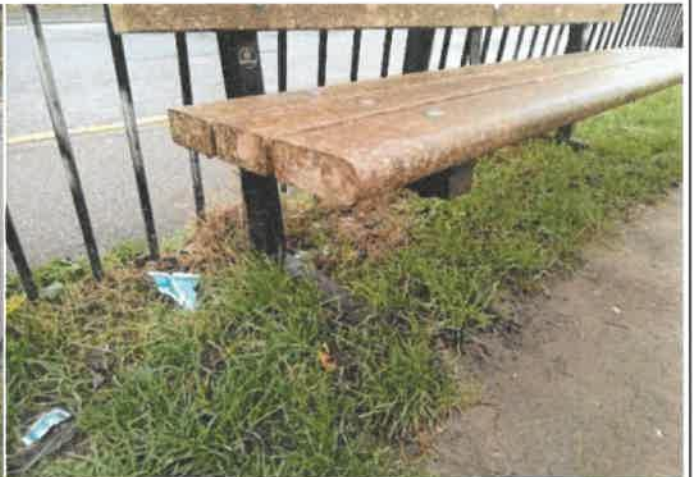
Finding: The paintwork on this item has been damaged or worn exposing the metal underneath which is rusting / corroding

Action: Treat affected areas and repaint

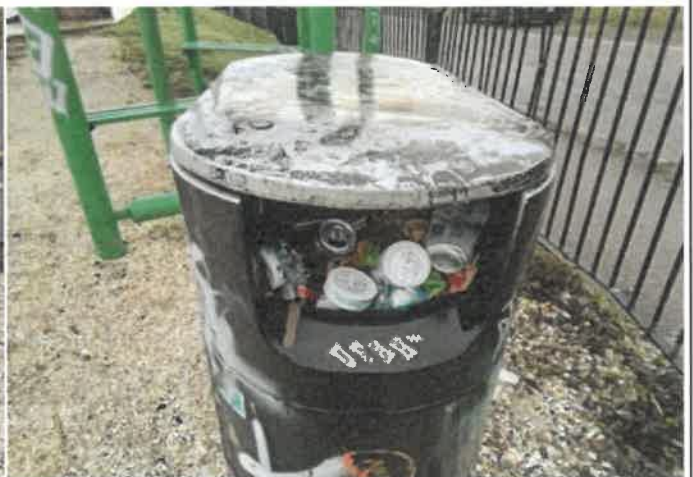
Finding: The litter bin is full

Action: Empty and review the collection routine
