**Members are summoned to attend a meeting of the
Community & Culture Committee
To be held on Tuesday 13 February 2024 at 7.00 pm.
at Leigh-on-Sea Community Centre, 71-73 Elm Road SS9 1SP
in order to transact the following items of business**

- a) Skate Park Inspection Report – for consideration
- b) DEC 2023-24 Certificate & Recommendation Report 2023-30 Leigh Community Centre – for consideration
- c) Community Centre expenditure – Chairman of F&G Committee to report
- d) Hire rates – report from Booking staff – for consideration

Inspected: 15-December-2023 - 08:15 by Alan Lingley (RPII Annual Inspector)

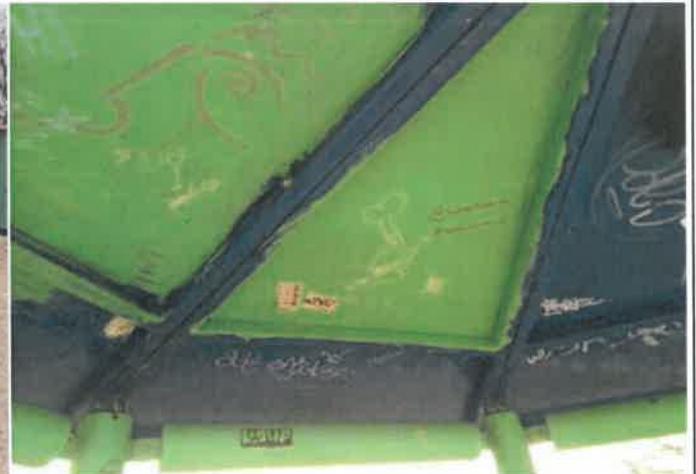
Finding: There is offensive graffiti present
Action: Remove as soon as practicable

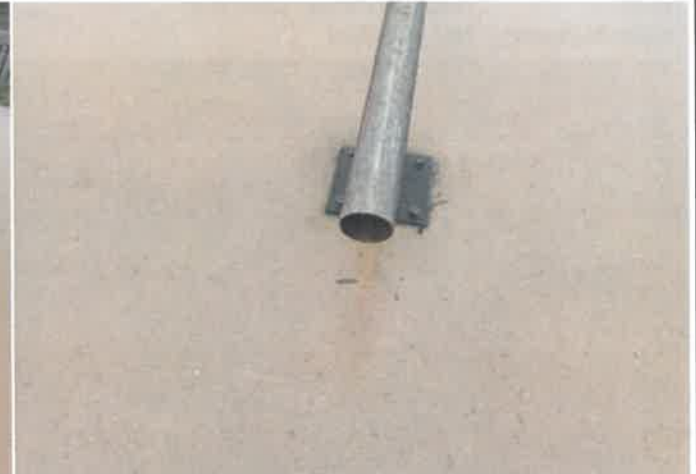
Finding: The ends of all coping rails should be sealed to meet the requirements of BS EN 14974
Action: Ensure all coping ends are sealed
