**Members are summoned to attend a meeting of the
Community & Culture Committee
To be held on Tuesday 13 February 2024 at 7.00 pm.
at Leigh-on-Sea Community Centre, 71-73 Elm Road SS9 1SP
in order to transact the following items of business**

- a) Skate Park Inspection Report – for consideration
- b) DEC 2023-24 Certificate & Recommendation Report 2023-30 Leigh Community Centre – for consideration
- c) Community Centre expenditure – Chairman of F&G Committee to report
- d) Hire rates – report from Booking staff – for consideration

Inspected: 15-December-2023 - 08:15 by Alan Lingley (RPII Annual Inspector)

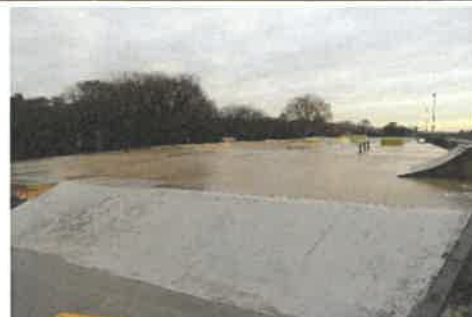
Finding 1
 A section of surfacing was incomplete at time of inspection - Complete the installation

Finding 2
 Home-made portable skate ramps are present on site - Remove

Finding 6
 The fence is severely damaged in places - Repair or replace all affected sections

Finding 11
 The rolling surface of the area is severely damaged - Repair all damaged surfaces

Finding 12
 The skate safety zone shall be a bound uniform and loose fill shall not be used - Remove loose fill and provide a bound surface

Finding 13
 The surface has eroded in some areas expsing large rocks and may be slippery in wet conditions - Remove rocks and reinstate the surface

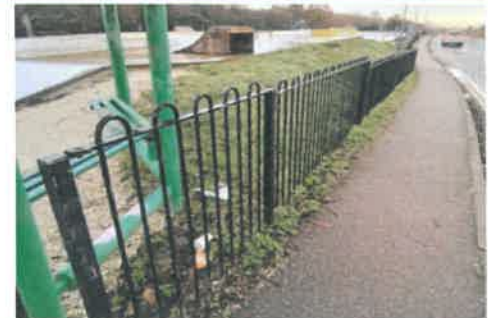
A section of fence is damaged and unsecured - Repair and secure

There is some damage to the fence sections - Monitor for any further deterioration and repair as required

There is some damage to the fence - Repair

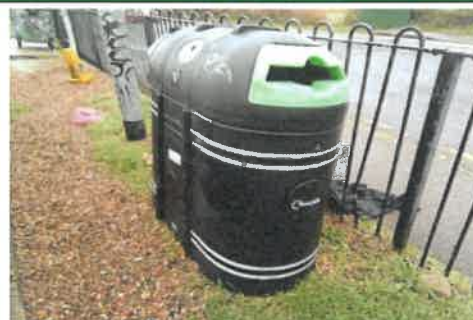
A number of fixing(s) have worked loose - Secure all loose fixings

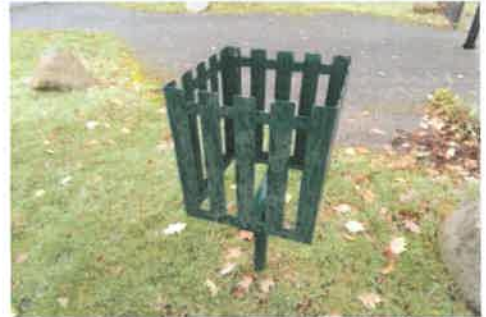
There is no liner present in the litter bin - Provide as required

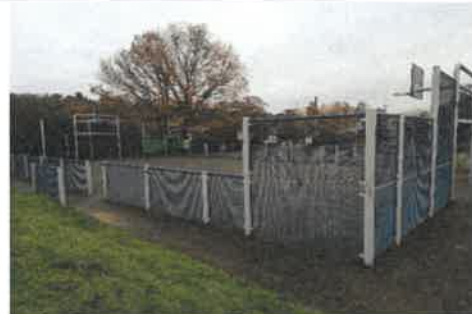
A clearly visible facility sign should be provided in a prominent position with the wording as detailed BS EN 15312- the equipment is not intended for children less than 3 years old- the warning - Do not climb on the framework or nets- the warning - Do not hang on the ring (if provided)- the warning - Do not wear rings or other jewellery- name and telephone number of the administrator- number to call in case of accident - Provide signage to BS EN 15312

The net is damaged - Replace

There is algae, silt or moss growth on the surface resulting in slippery conditions - Clean and treat appropriately

A number of fixing(s) have worked loose - Secure all loose fixings

There is/are finger entrapments in the panels and the item fails to meet the requirements of BS EN 15312 Clause 4.4.2.2 Entrapment of fingers - Monitor - No remedial work recommended

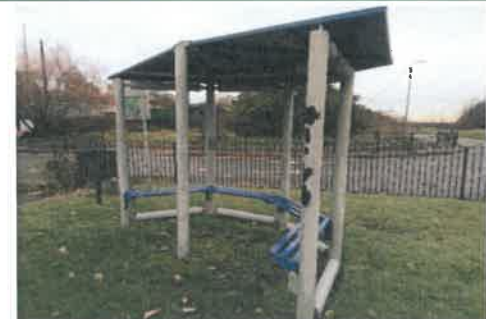
The paintwork on this item has been damaged or worn exposing the metal underneath which is rusting / corroding - Treat affected areas and repaint

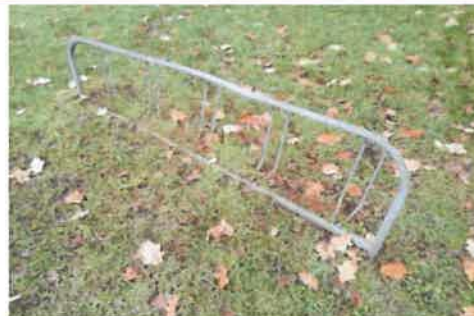
There is some damage to the item - Monitor for any further deterioration and repair as required

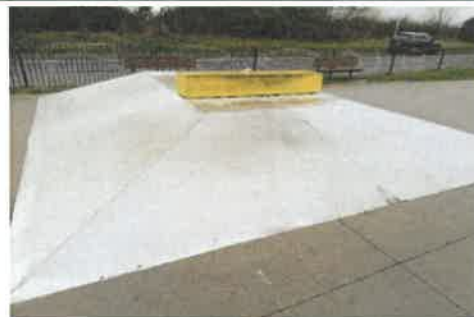
The riding surface of the ramp is damaged - Repair all damaged surfaces

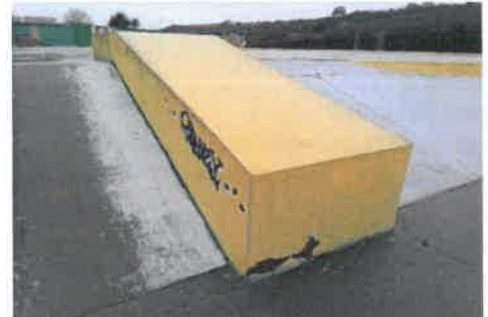
There is damage to the grind box - Repair the box

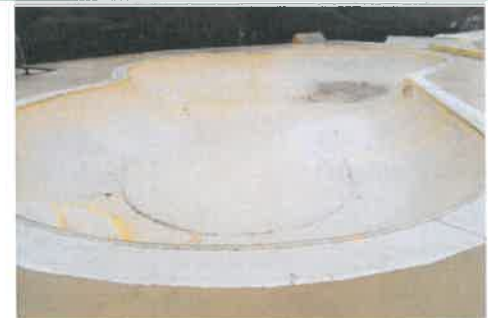
There is standing water within the bowl and the drain cover is damaged - Replace the drain cover and ensure the water drains freely

The riding surface of the ramp has some cracks apparent - Monitor for any further deterioration and repair as required

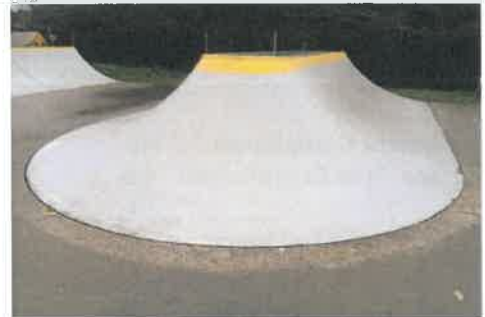
The riding surface of the ramp is damaged - Repair all damaged surfaces

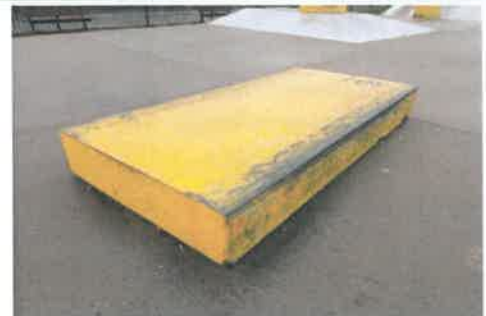
The item has been damaged - Monitor for any further deterioration and replace as required

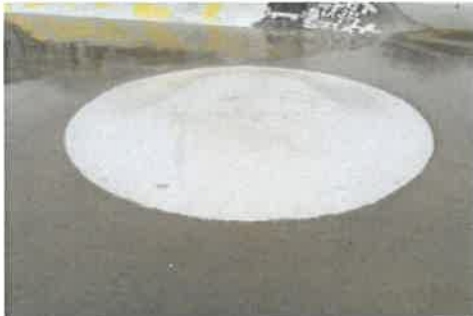
Finding 1
This item is satisfactory - no work required -

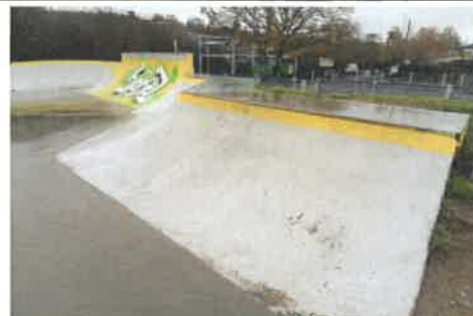
The surface has eroded in some areas exposing the concrete foundations - Reinstate the surface

The adjacent rolling surface does not meet with the requirements of BS EN 14974 - Monitor - No remedial work recommended

The item has insufficient safety zone allowed as required by BS EN 14974. This should equal at least 2.0 metres on most items. - Monitor - No remedial work recommended

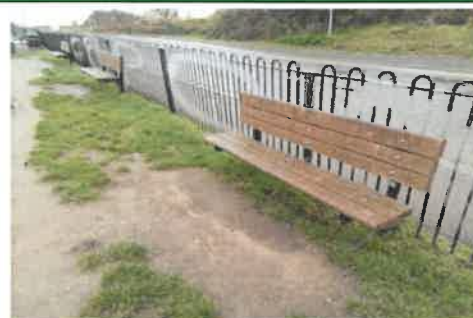
The paintwork on this item has been damaged or worn exposing the metal underneath which is rusting / corroding - Treat affected areas and repaint

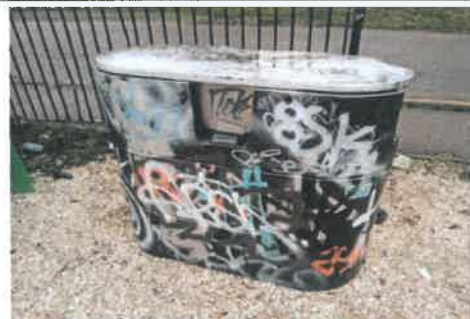
The litter bin is full - Empty and review the collection routine

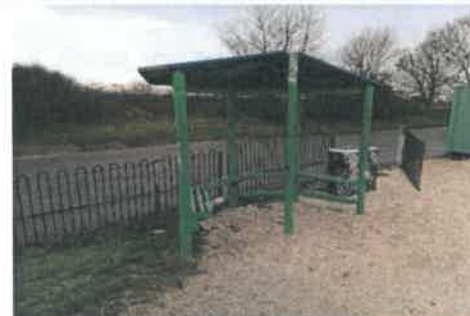
There is offensive graffiti present - Remove as soon as practicable

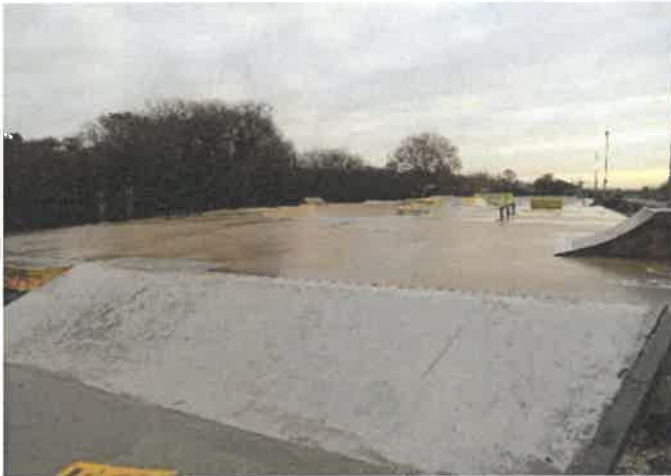
Finding: Home-made portable skate ramps are present on site **Action:** Remove

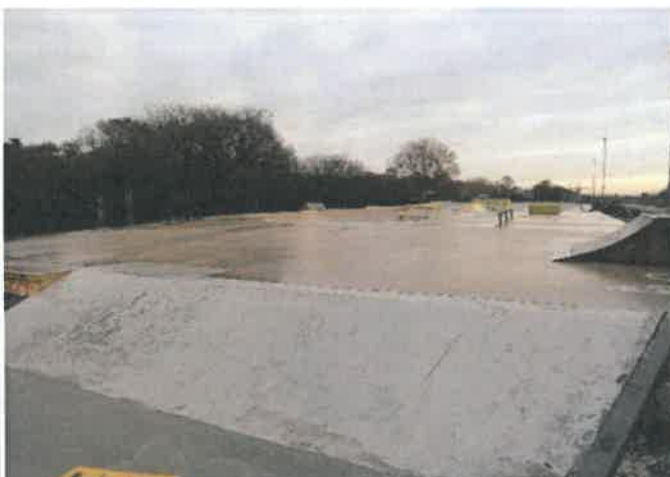
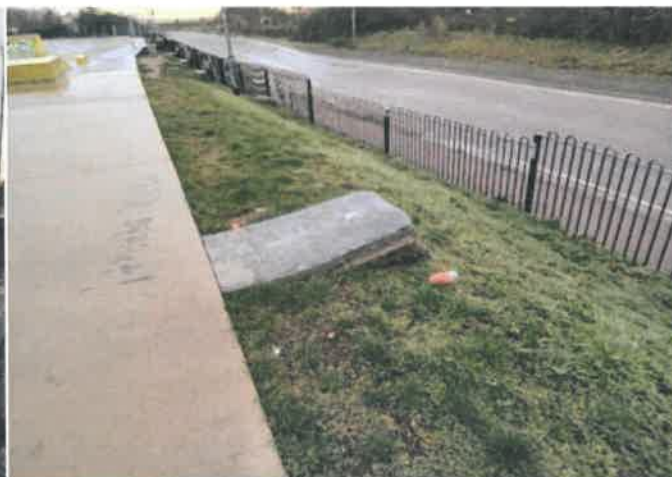
Finding: There is what appears to be a self made jump ramp which may encourage users to jump the fence

Action: Remove

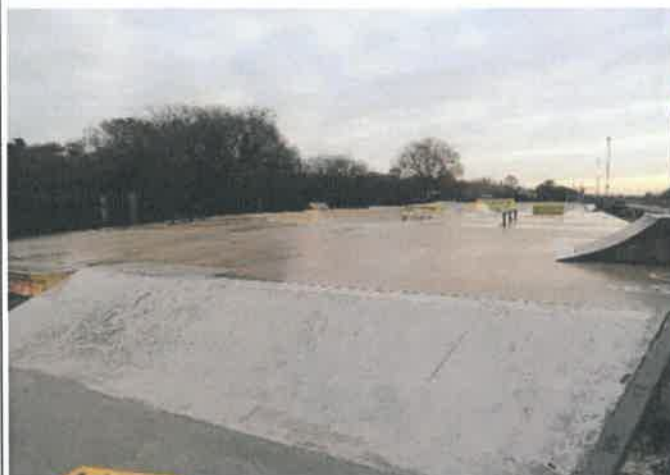
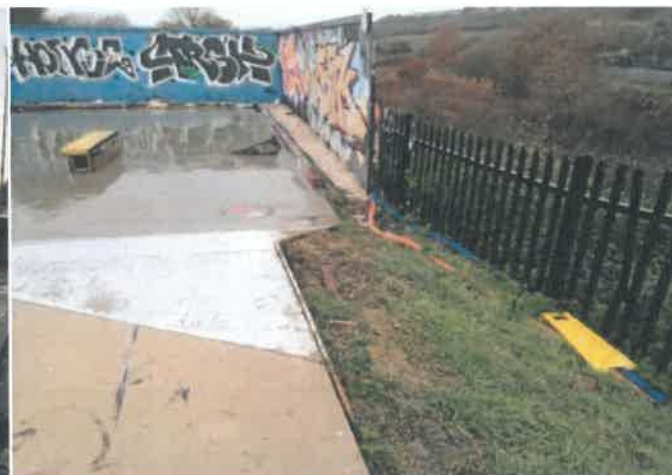
Finding: The fence is within close proximity to the area

Action: Monitor use and review risk assessment regularly

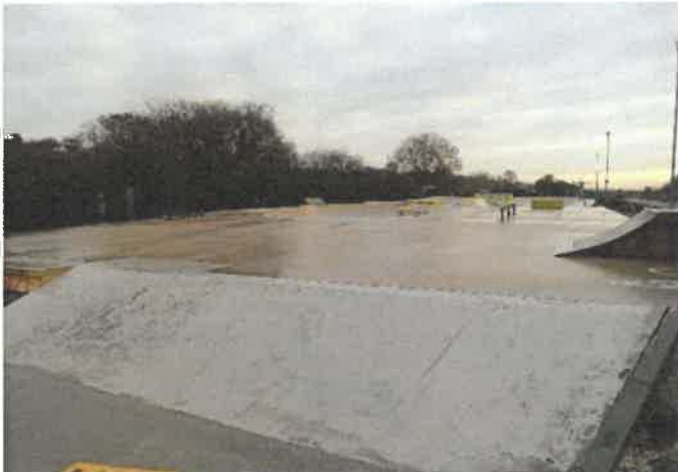
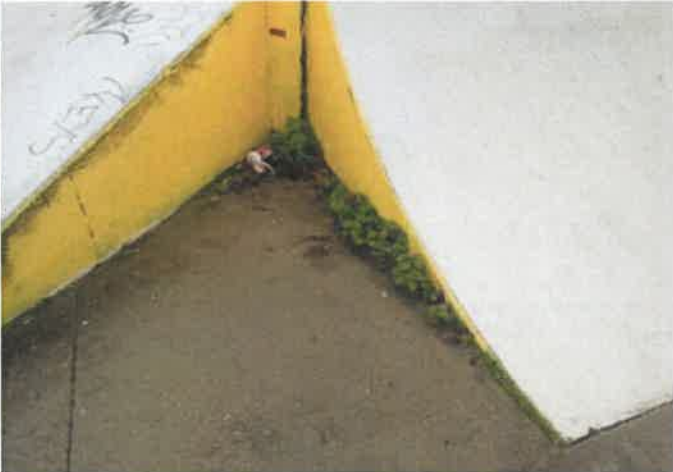
Finding: There is weed / vegetation growth on, between, or around the edges of the surfacing **Action:** Remove weed / vegetation growth

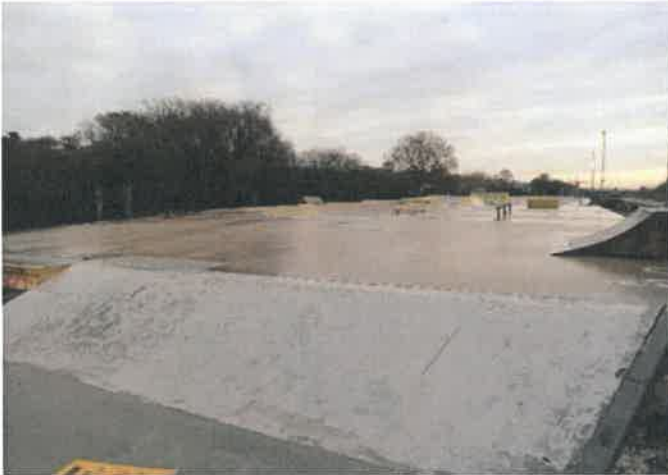
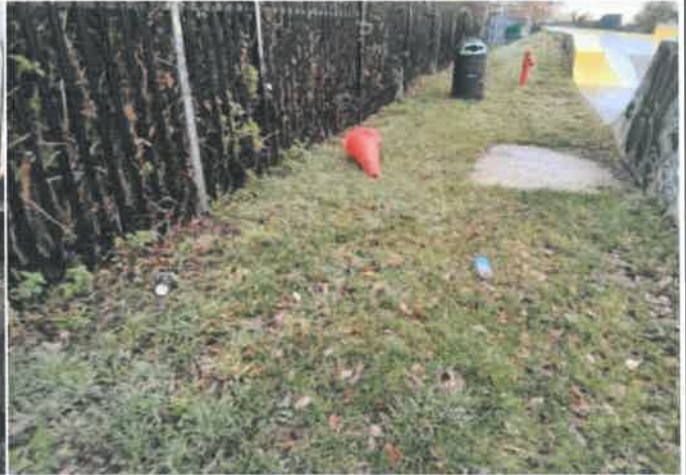
Finding: There is litter/debris in the area

Action: Remove litter/debris from the area and maintain

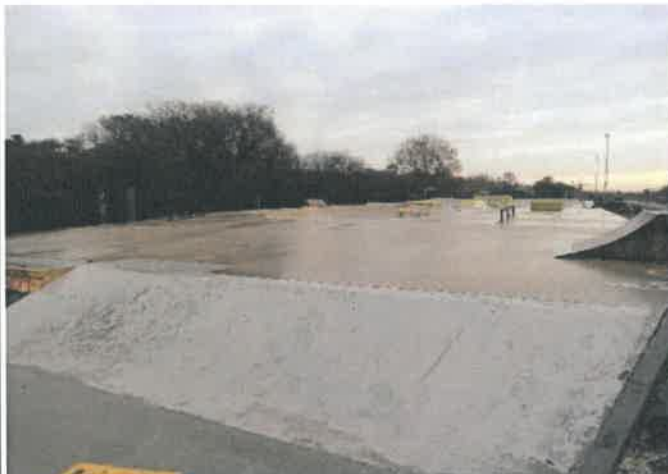
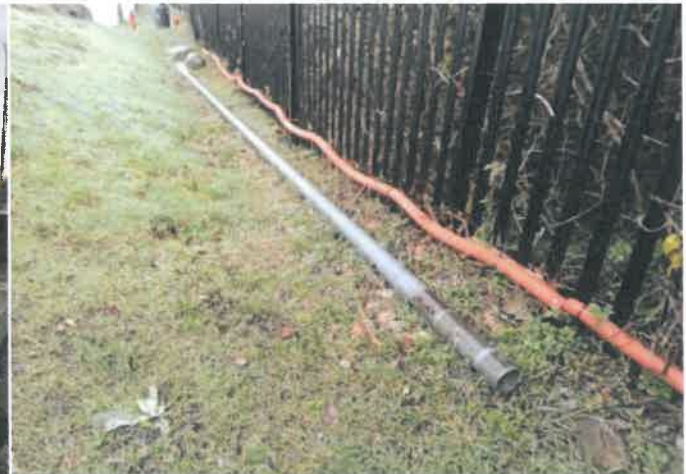
Finding: There is a lighting post in area

Action: Remove

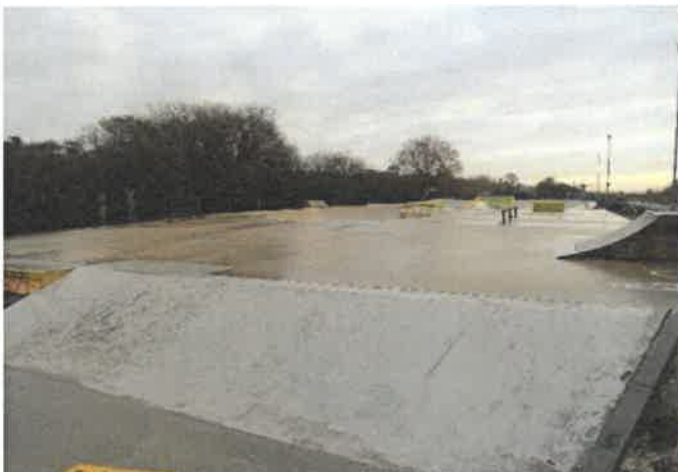
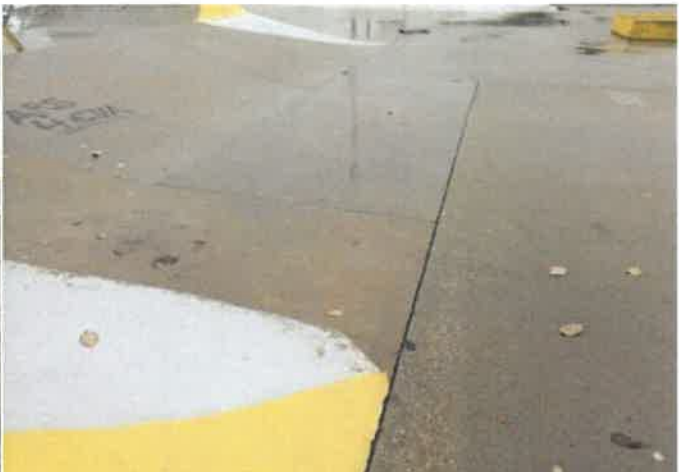
Finding: Joints between the riding surfaces should not be greater than 5mm to meet the requirements of BS EN 14974 **Action:** Take corrective action to ensure that the gaps between the joints do not exceed 5mm

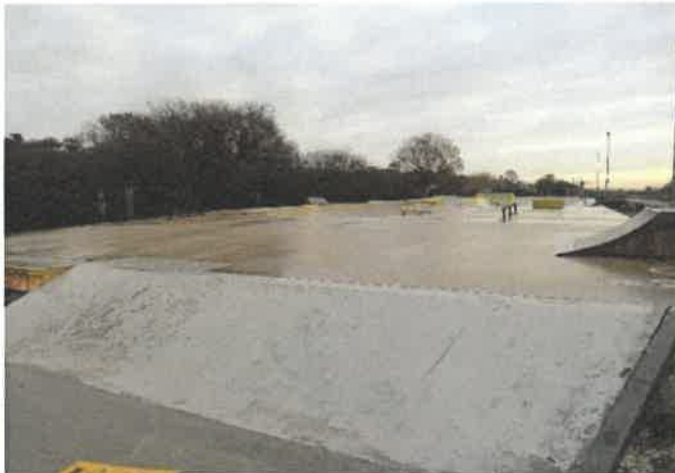
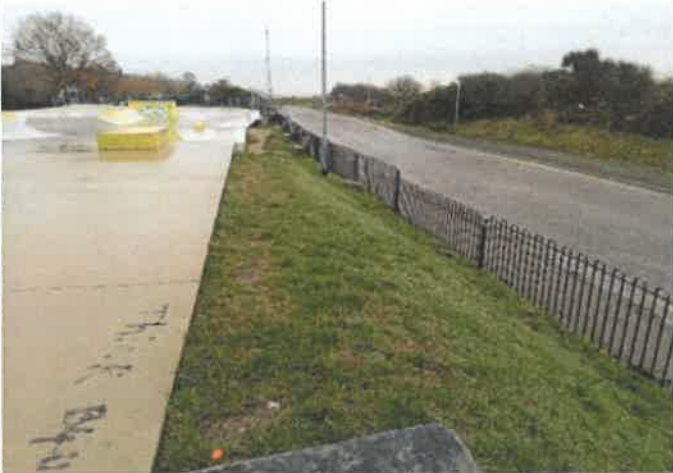
Item:	Ancillary Items - Site General	Risk Level:	L - Low Risk
Manufacturer:	Owner/Operator	Surface:	N/A

Finding: There is the potential for users to become out of control when descending the mound and impact the fence

Action: Monitor and review the risk assessment regularly

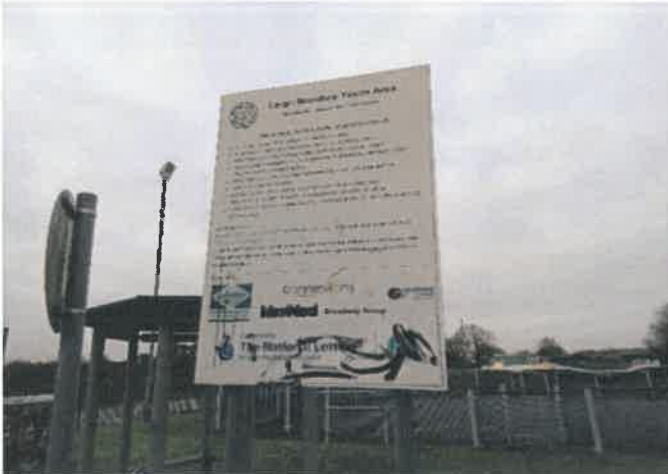
Item: Ancillary Items - Sign
Manufacturer: Owner/Operator

Finding: There is some graffiti present

Action: Remove the graffiti

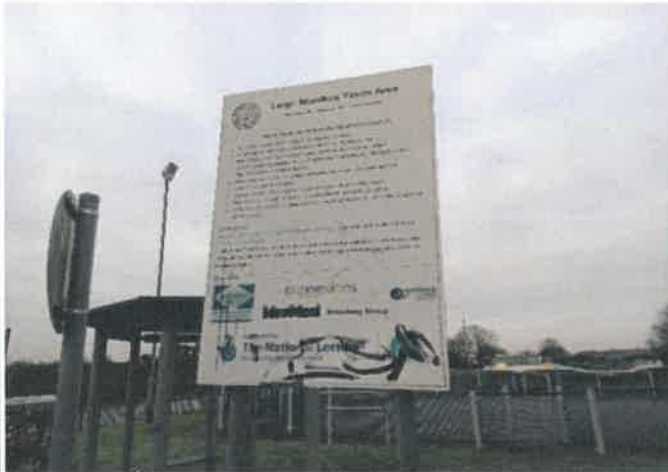
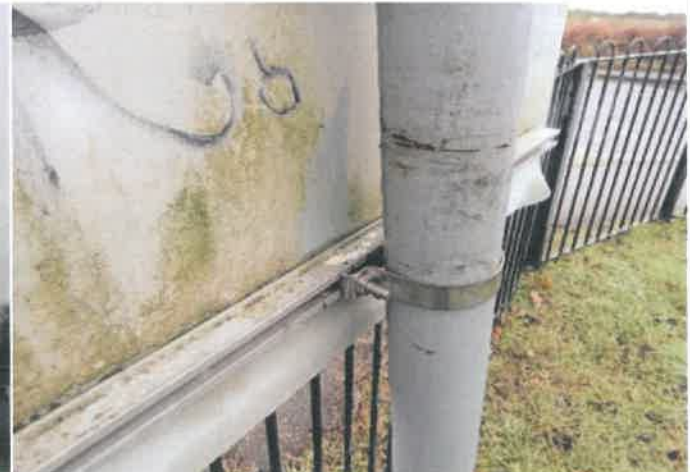
Item: Ancillary Items - Sign
Manufacturer: Owner/Operator

Finding: There are projecting bolt thread(s) present

Action: Remove excess thread length and deburr or provide cap

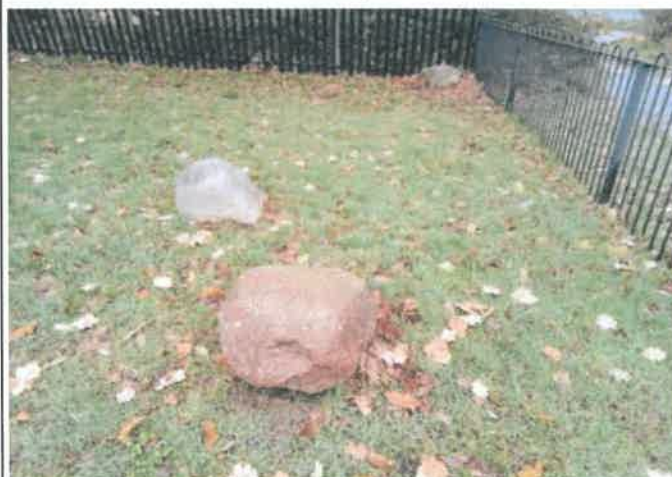
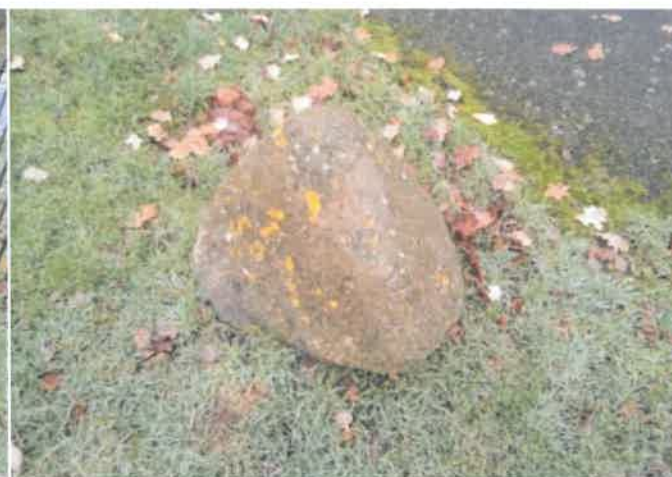
Item: Ancillary Items - Boulders
Manufacturer: Natural Feature

Finding: The rocks and/or boulders have moss/algae growth apparent

Action: Clean and maintain

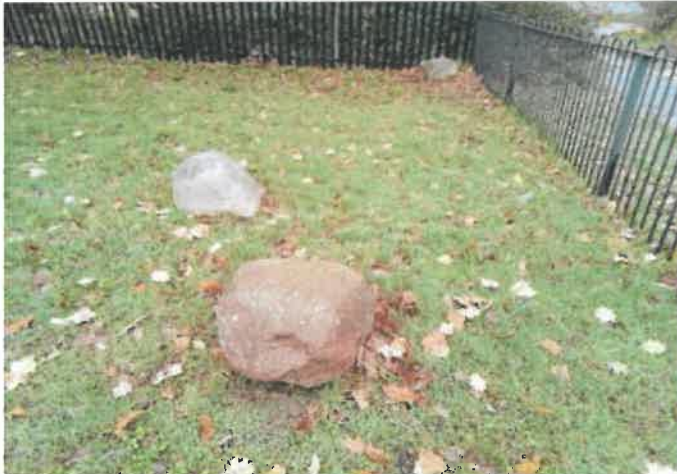
Item: Ancillary Items - Boulders
Manufacturer: Natural Feature

Finding: The boulders are not secured into position

Action: Secure the boulders

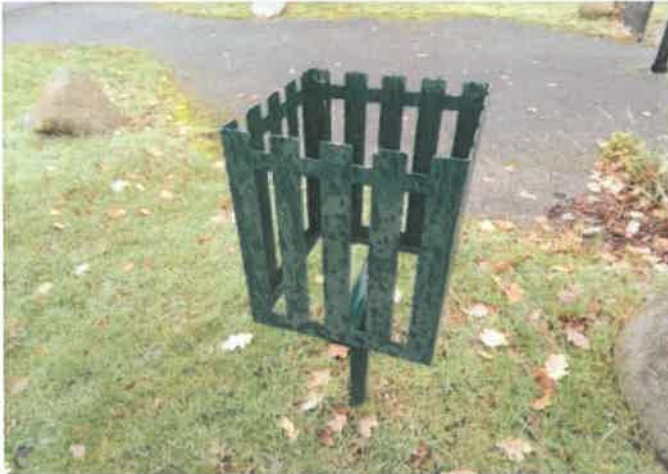
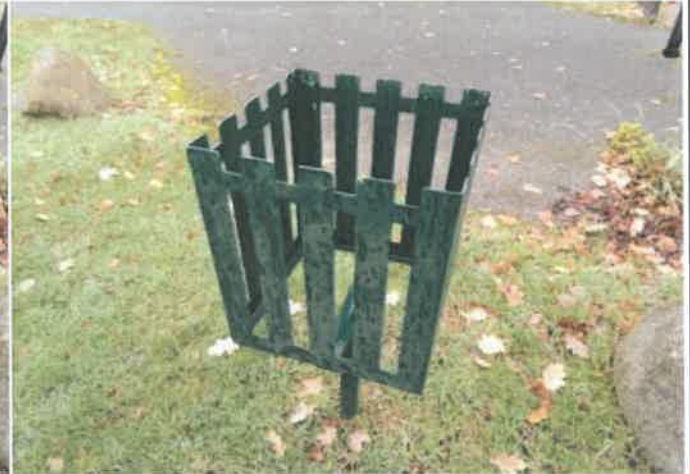
Item: Ancillary Items - Litter Bin
Manufacturer: Not Identified

Finding: There is no liner present in the litter bin

Action: Provide as required

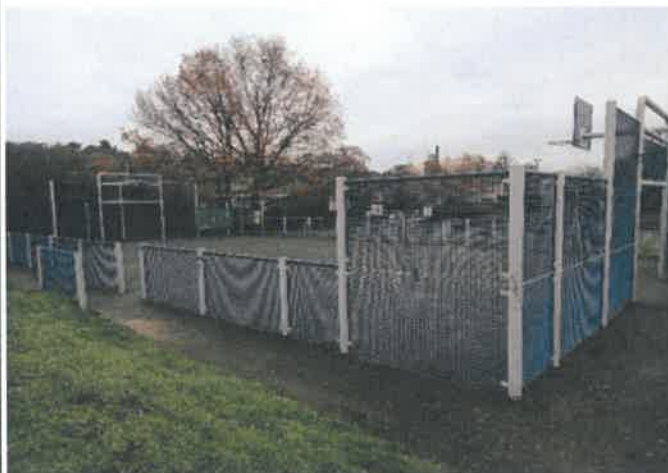
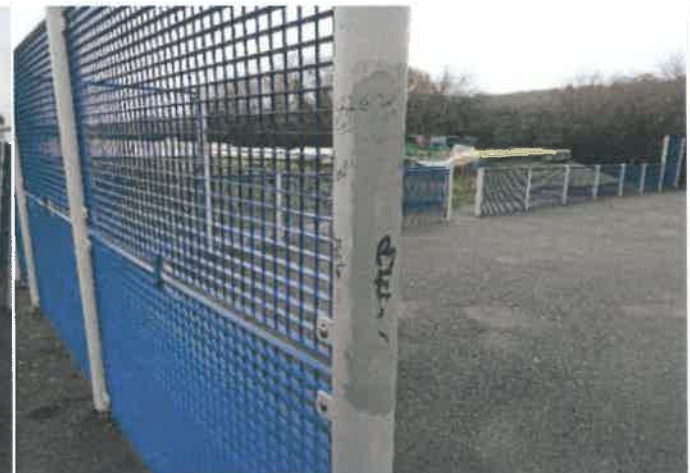
Item: Multi Use Games Area - Multi Use Games Area (MUGA)
Manufacturer: Not Identified

Finding: There is some graffiti present

Action: Remove the graffiti

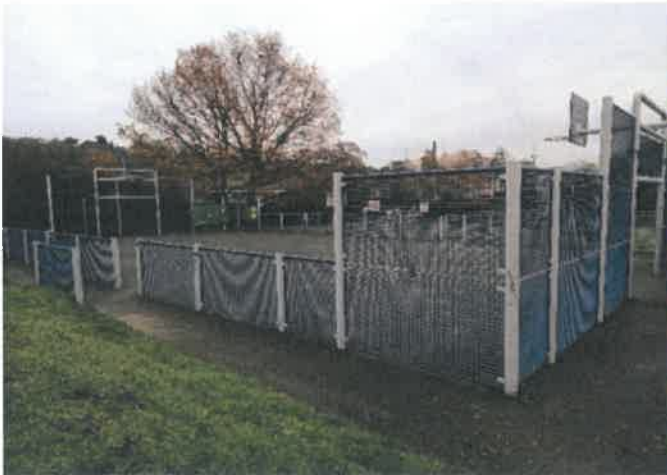
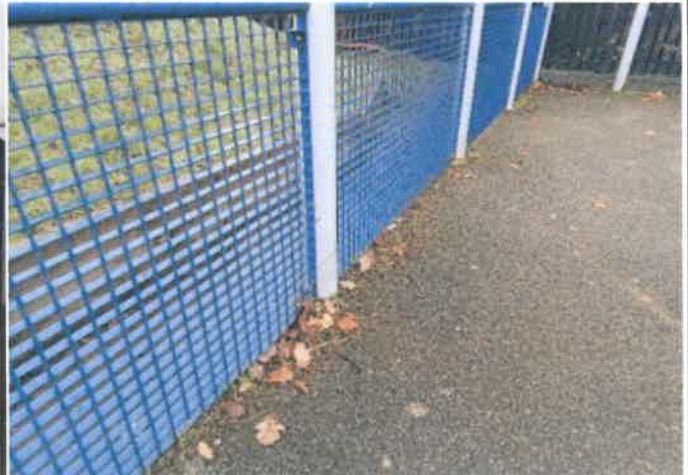
Item: Multi Use Games Area - Multi Use Games Area (MUGA)
Manufacturer: Not Identified
Risk Level: L - Low Risk
Surface: Bitmac

Finding: There is weed / vegetation growth on, between, or around the edges of the surfacing
Action: Remove weed / vegetation growth

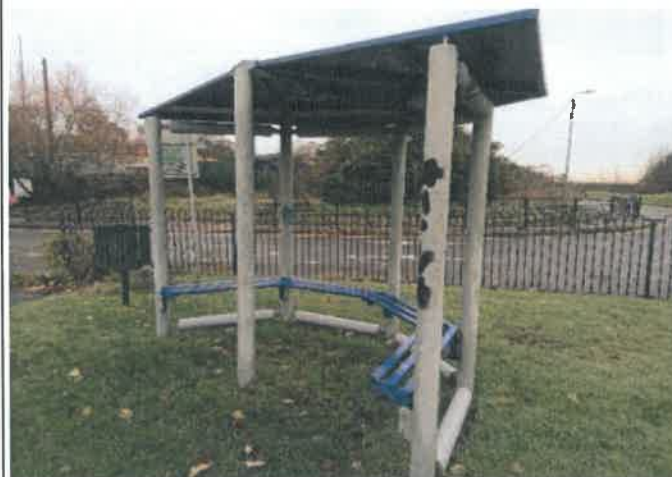
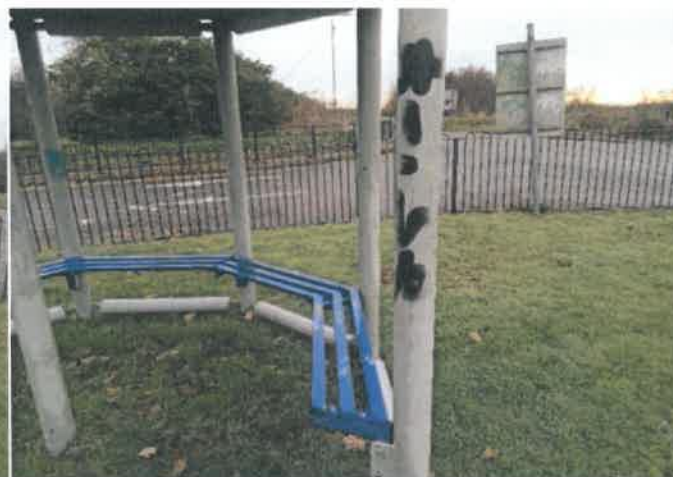
Item: Ancillary Items - Shelter
Manufacturer: Not Identified
Risk Level: N - Risk Assessment not Undertaken
Surface: N/A

Finding: There is some graffiti present
Action: Remove the graffiti

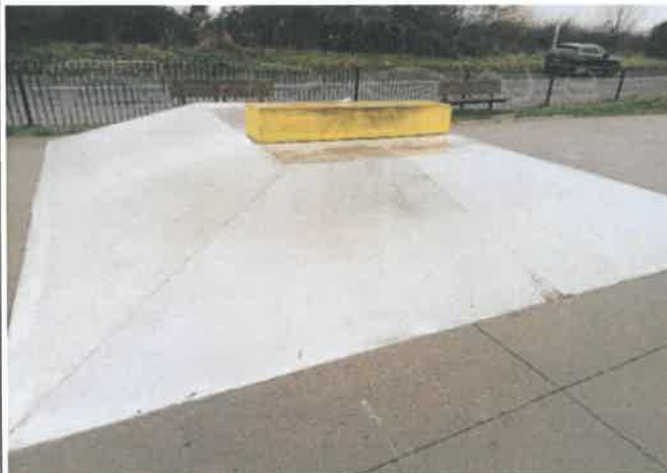
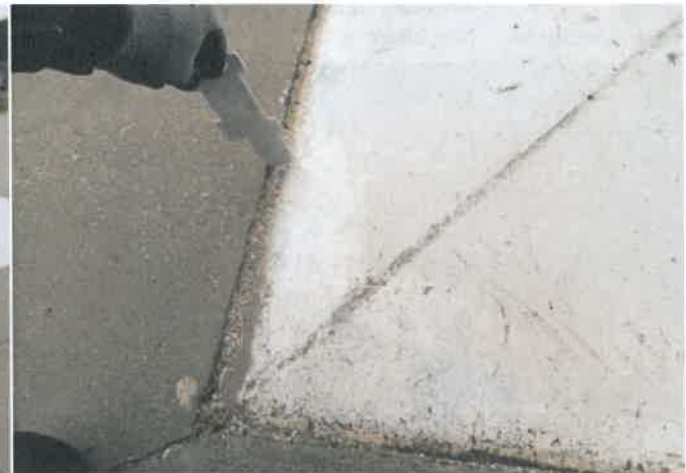
Item: Wheeled Sports - Fun Box
Manufacturer: Not Identified

Finding: Height differences between the riding surfaces should not be greater than 3mm in height to meet the requirements of BS EN 14974

Action: Take corrective action to ensure that the gaps between the joints do not exceed 3mm

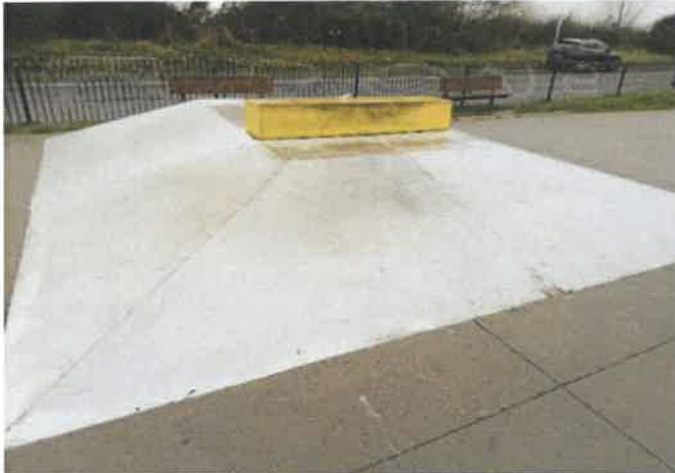
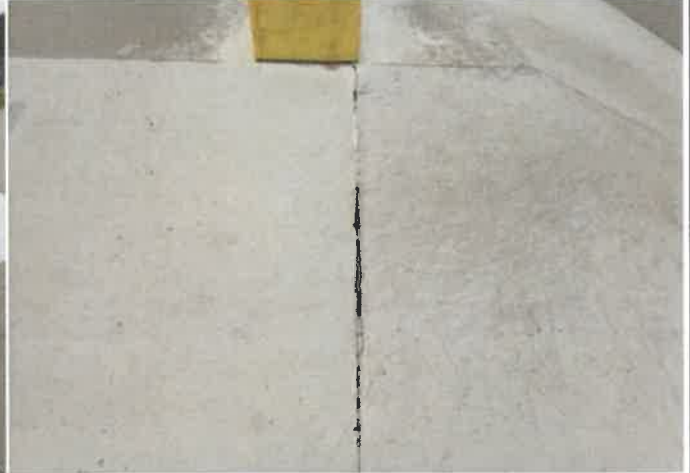
Item: Wheeled Sports - Fun Box
Manufacturer: Not Identified

Finding: Joints between the riding surfaces should not be greater than 5mm to meet the requirements of BS EN 14974
Action: Take corrective action to ensure that the gaps between the joints do not exceed 5mm

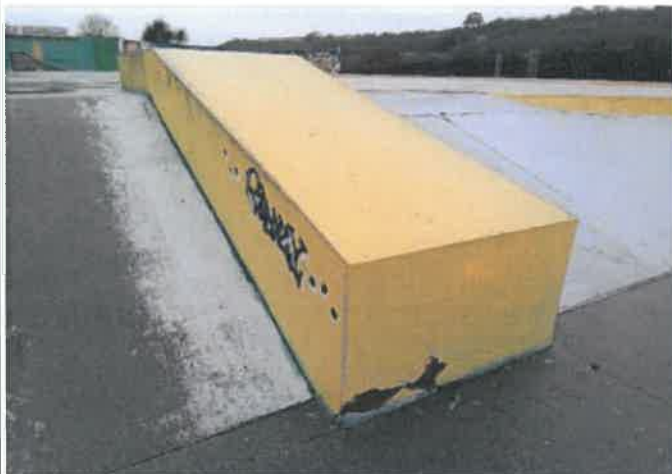
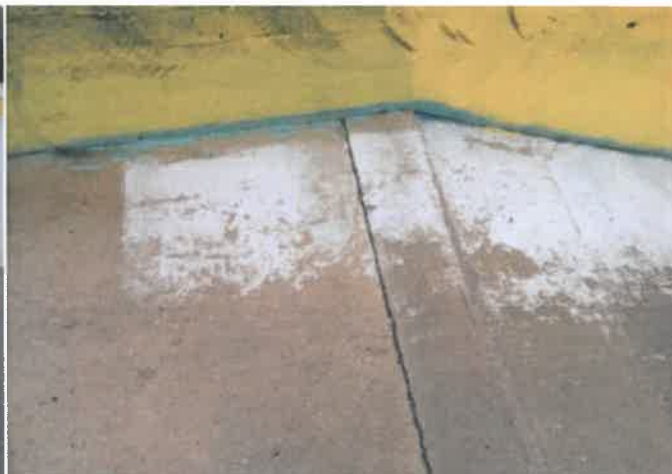
Item: Wheeled Sports - Grind Box
Manufacturer: Not Identified

Finding: Joints between the riding surfaces should not be greater than 5mm to meet the requirements of BS EN 14974
Action: Take corrective action to ensure that the gaps between the joints do not exceed 5mm

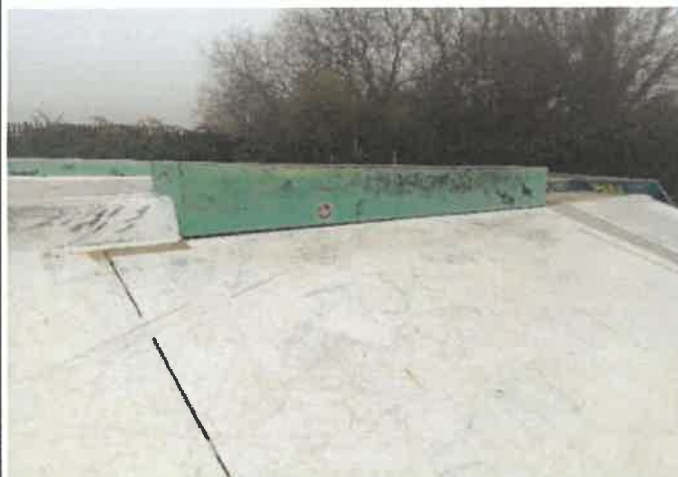
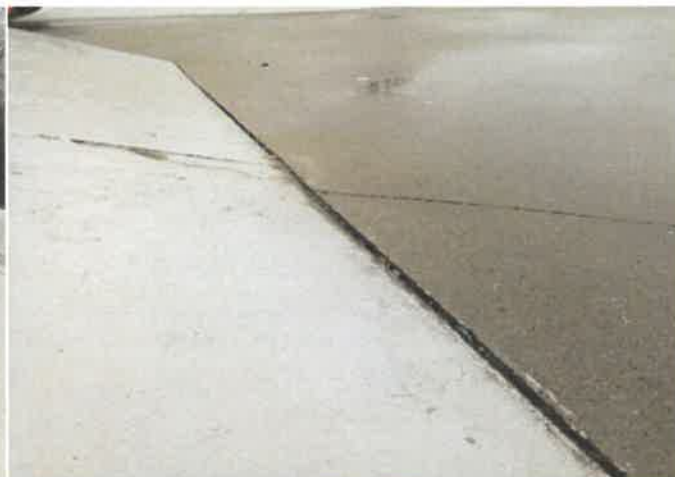
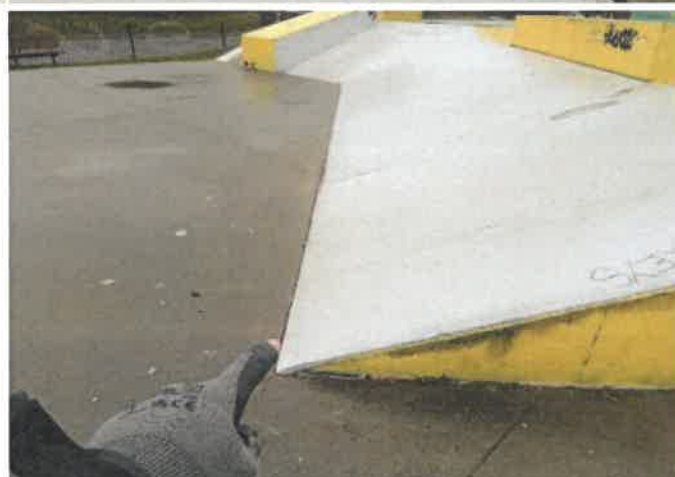
Item: Wheeled Sports - Grind Box
Manufacturer: Not Identified

Finding: Height differences between the riding surfaces should not be greater than 3mm to meet the requirements of BS EN 14974
Action: Take corrective action to ensure that the gaps between the joints do not exceed 3mm

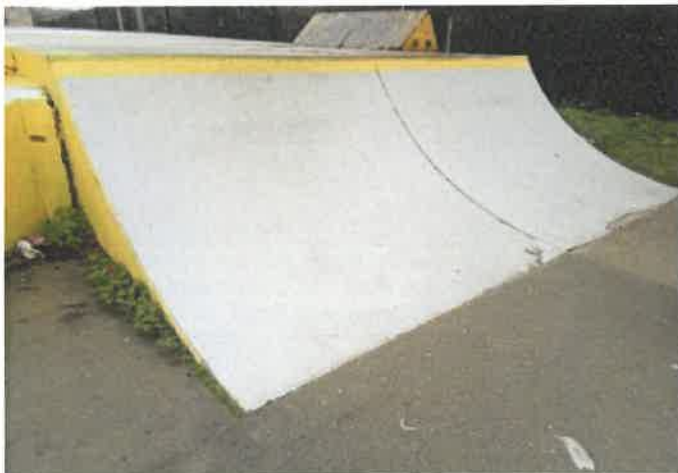
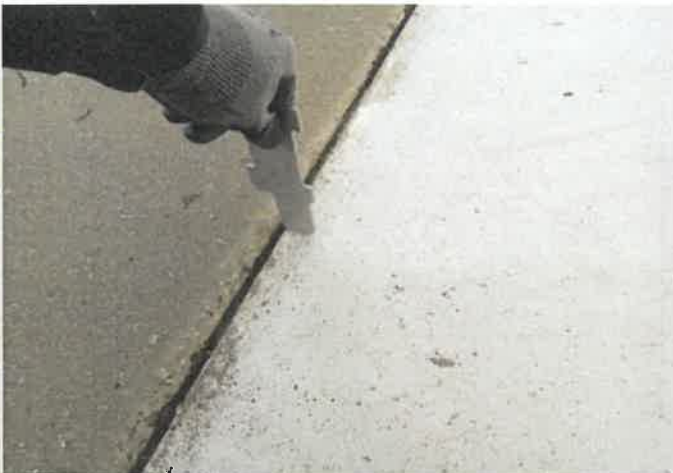
Item:	Wheeled Sports - Quarter Pipe	Risk Level:	L - Low Risk
Manufacturer:	Not Identified	Surface:	Concrete

Finding: Height differences should not be greater than 3mm to meet the requirements of BS EN 14974 **Action:** Take corrective action to ensure that the gaps between the joints do not exceed 3mm

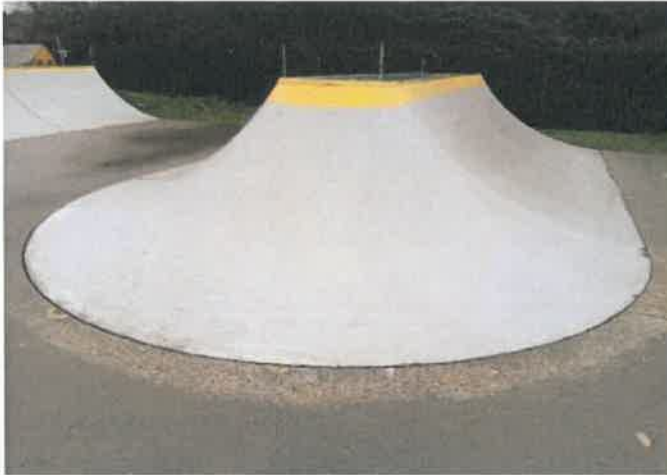
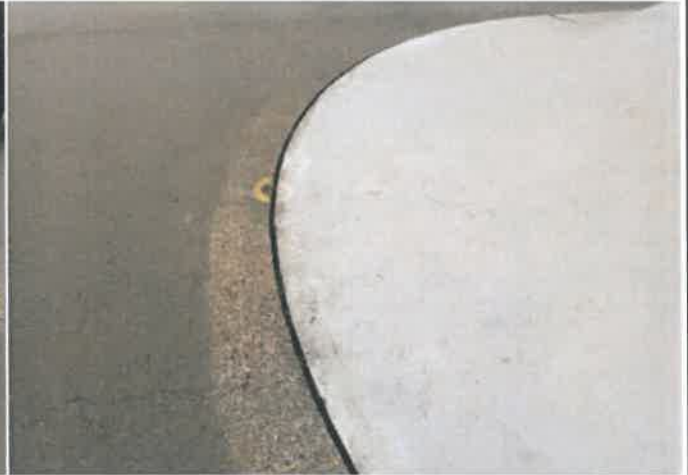
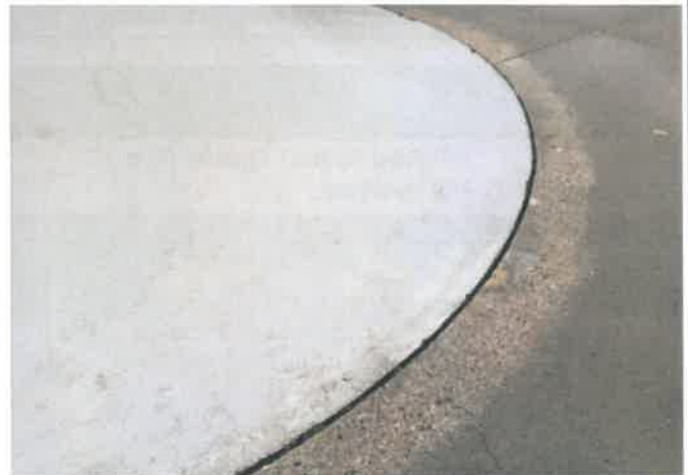
Item: Wheeled Sports - Volcano
Manufacturer: Not Identified

Finding: Joints between the riding surfaces should not be greater than 5mm to meet the requirements of BS EN 14974 **Action:** Take corrective action to ensure that the gaps between the joints do not exceed 5mm

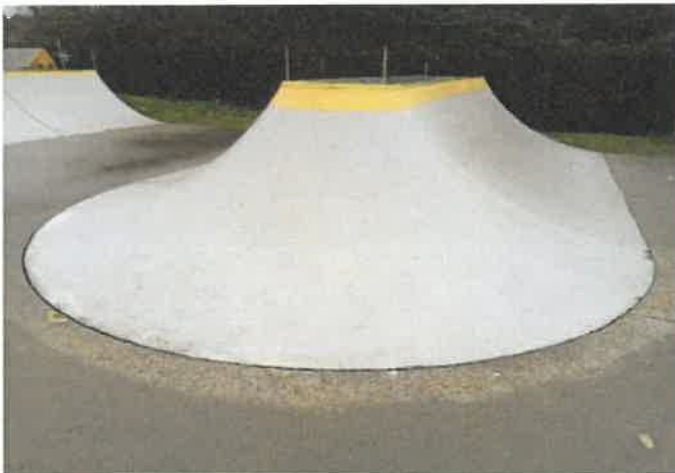
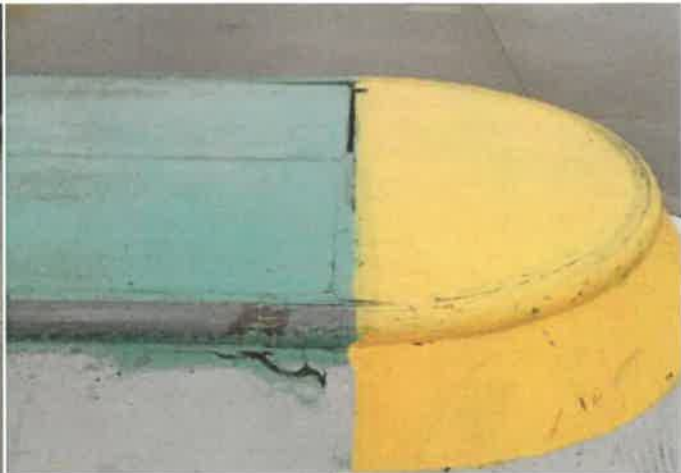
Item:	Wheeled Sports - Volcano	Risk Level:	L - Low Risk
Manufacturer:	Not Identified	Surface:	Concrete

Finding: Joints between the riding surfaces should not be greater than 5mm to meet the requirements of BS EN 14974 **Action:** Take corrective action to ensure that the gaps between the joints do not exceed 5mm

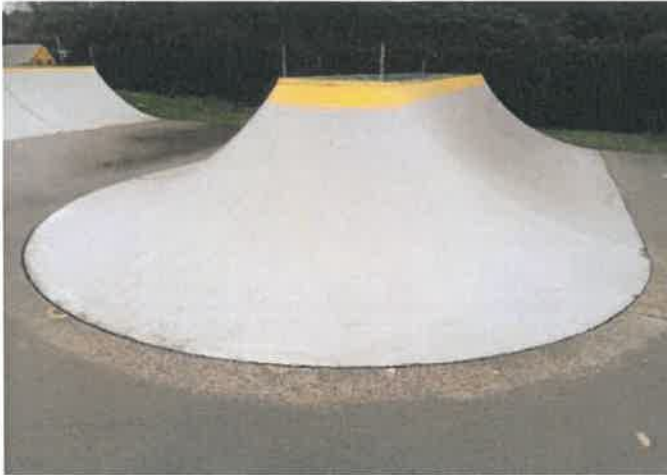
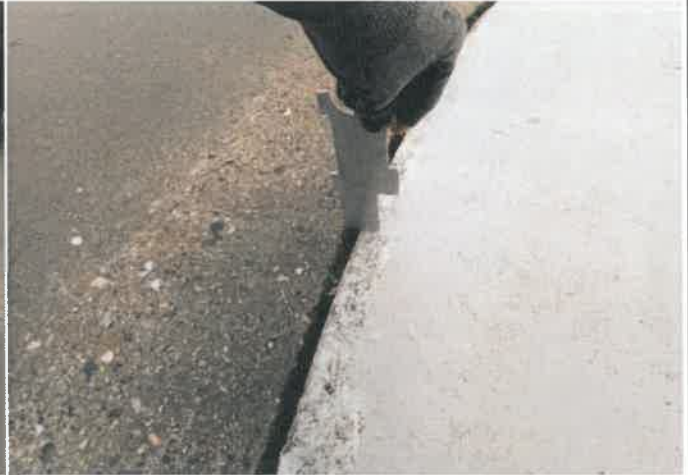
Item: Wheeled Sports - Volcano
Manufacturer: Not Identified

Finding: Height differences between the riding surfaces should not be greater than 3mm to meet the requirements of BS EN 14974
Action: Take corrective action to ensure that the gaps between the joints do not exceed 3mm

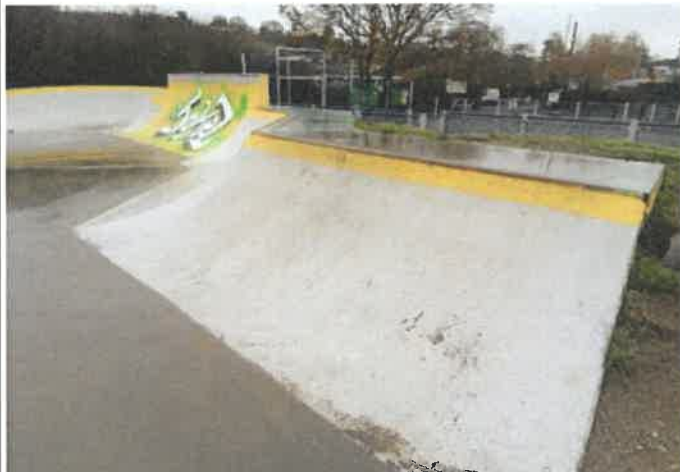
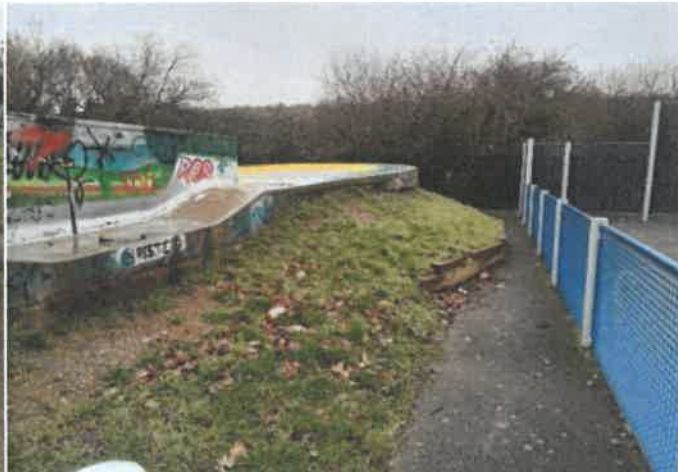
15 - Moderate Risk (Finding 3)			
Item:	Wheeled Sports - Bank	Risk Level:	M - Moderate Risk
Manufacturer:	Not Identified	Surface:	Concrete

Finding: It is foreseeable that users will attempt to jump over the fence and into the MUGA, or any accidental loss of control may result in impacting the side panels (fence)		Action: Refer to the contractor / designer

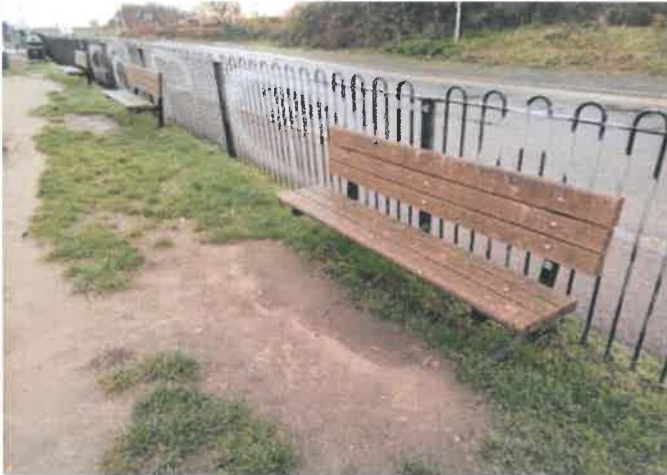
Item: Ancillary Items - Bench
Manufacturer: Not Identified

Finding: The bench is secured via cable ties

Action: Secure with a permanent fixing

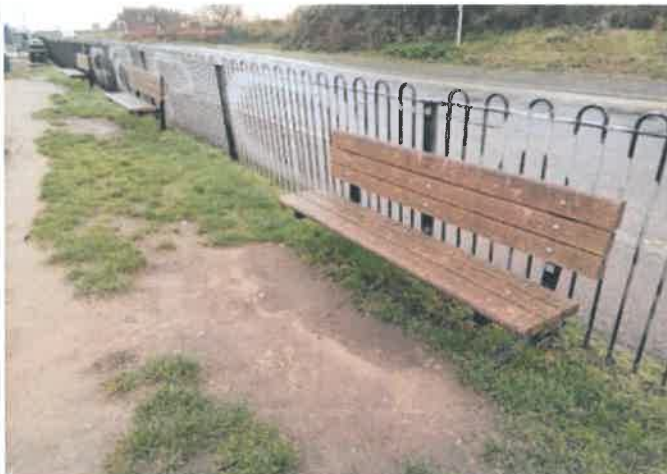
Item: Ancillary Items - Bench
Manufacturer: Not Identified

Finding: The area around the item has eroded and may become slippery

Action: Reinstate eroded area

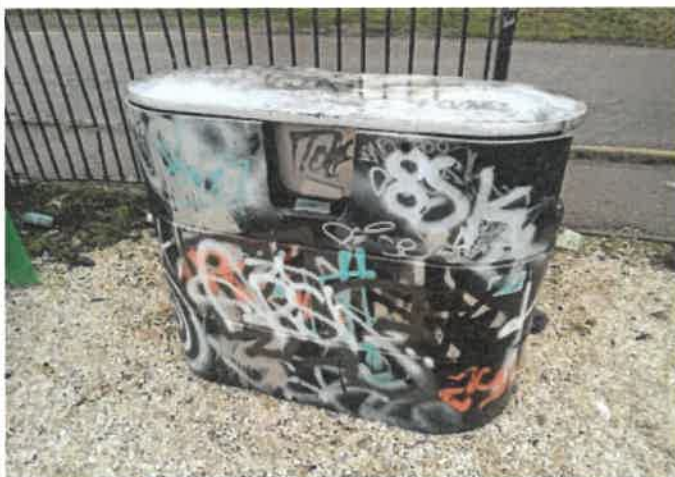
Item: Ancillary Items - Litter Bin
Manufacturer: Not Identified
Risk Level: L - Low Risk
Surface: Crushed Stone

Finding: The litter bin is full

Action: Empty and review the collection routine

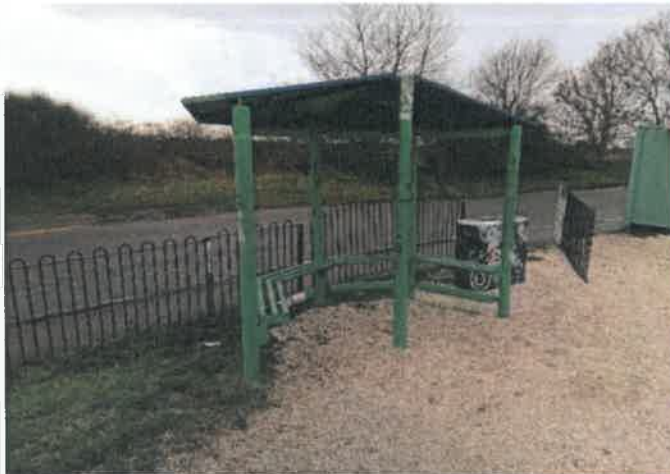
Item: Ancillary Items - Shelter
Manufacturer: Not Identified
Risk Level: V - Very Low Risk
Surface: Crushed Stone

Finding: There is offensive graffiti present
Action: Remove as soon as practicable
